PSI Center for Accelerator Science
and Engineering

Radiation damage to MHP45/46 magnetically coupled linear drive

M. Sapinski
PSI, HIMB Instrumentation meeting, 23 March 2026

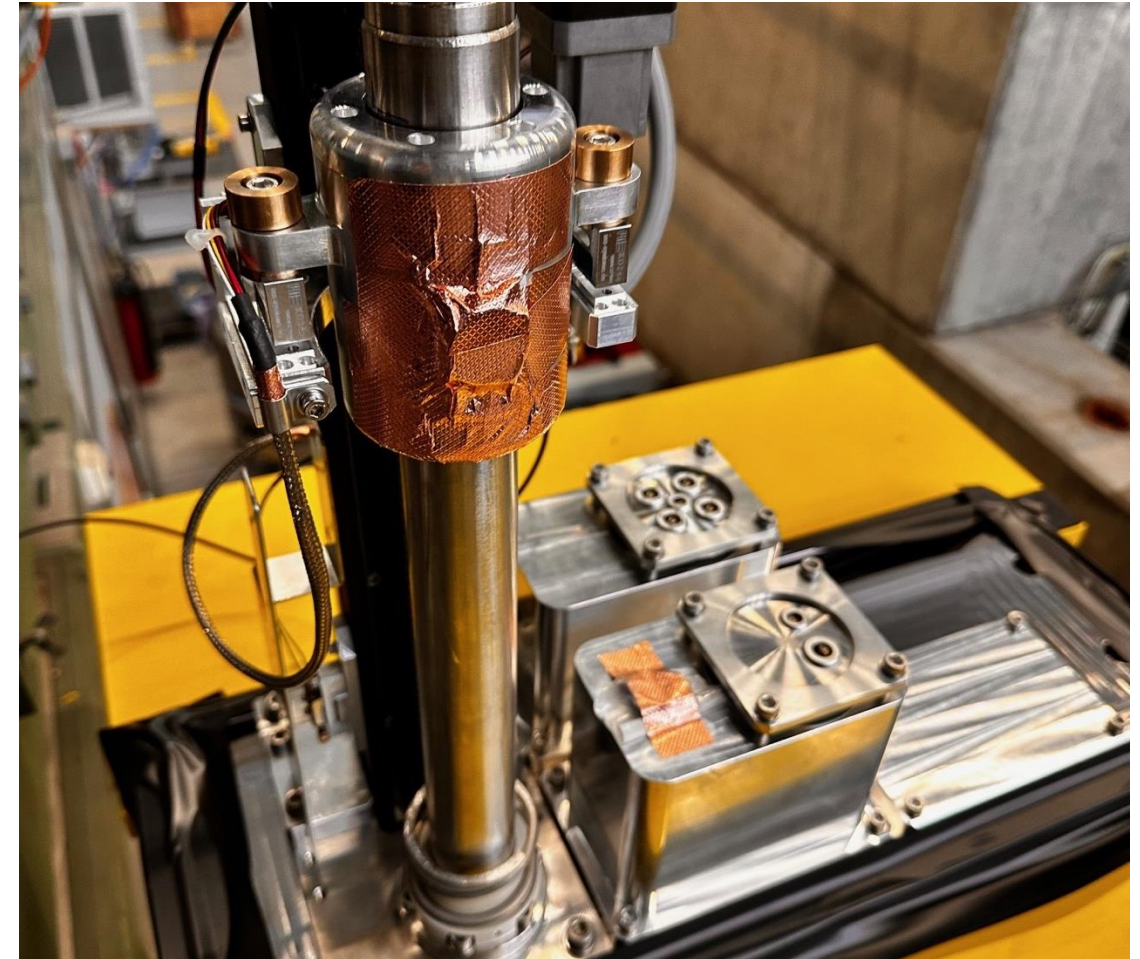
Reading of activation foils

Two activation foils installed, weighting 15.8 g each in 2024:

- On the linear drive
- On the protective shield

Composition: Permendur samples, proposed by Roman Galeev, main components Fe and Co.

Activation after removal on March 17, 2026:

- 1.3 mSv/h (Oberflasche) for foil on the shield.
- 0.91 mSv/h for the linear drive.

Back of an envelope calculation gives 10^{13} - 10^{14} n/cm²

To do: obtain neutron fluence from this.

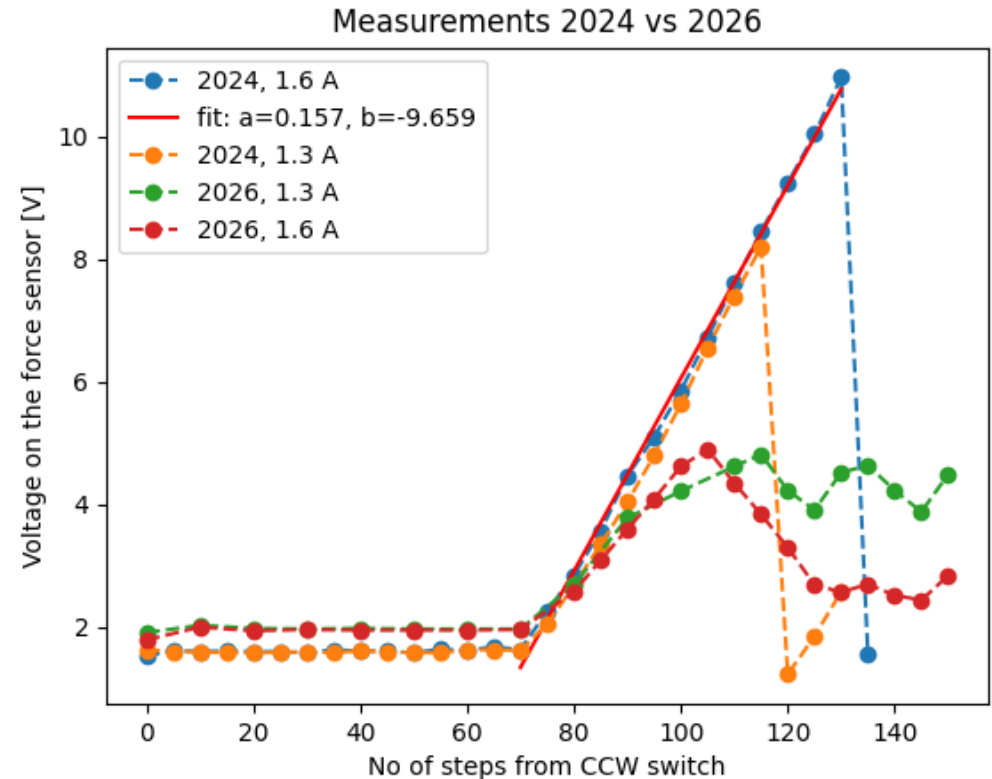
Measurements in 2024 show clear linear dependence and force reaching 270 N (10 V).

Data from last week look very much degraded. Is that magnet damage? I see also polarity flip (negative voltages) at high step count.

Also: at 1.3 A we lost about 30 steps, at 1.6 A no steps were lost.

1. The fluence registered on the outside of the linear drive seems to be $\sim 10^{14}$ n/cm², so far away from level of 10^{17} n/cm² at which NbFe magnets loose their magnetisation. Both numbers have to be confirmed.
2. MHP45/46 performed correctly in December 2025.
3. Magnet strength measurements were difficult, but several sessions gave similar results suggesting degradation of the magnets. Or maybe problem with measurement procedure?
4. Piezoelectric sensors are also sensitive to radiation. Radiation damage can also affect the sensor. Typical effect is baseline drift which we probably see in the initial „plateau”.

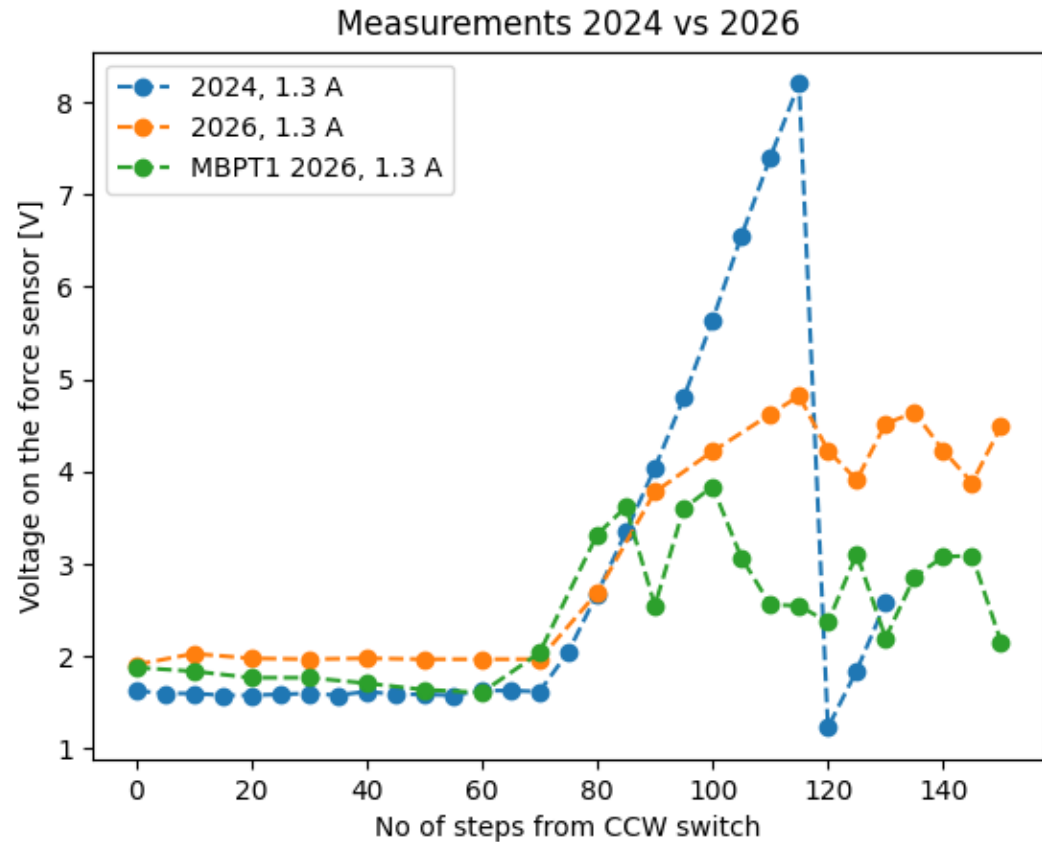
MBPT1 Magnet strength measurements

- Puzzling outcome.
- MBPT1 is installed since 2023.
- In 2025 no scan was done with this test monitor. Last scan: October 2024.
