# Strahentwicklung October 10<sup>th</sup>, 2024

## – MXB2B and RRL

M. Sapinski  
PSI, Oct 16<sup>th</sup>, 2024

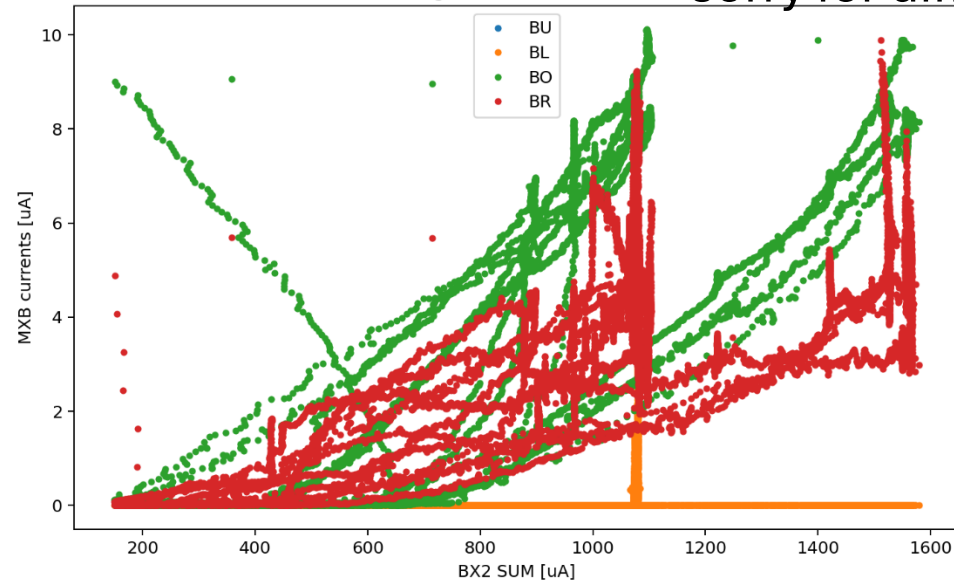
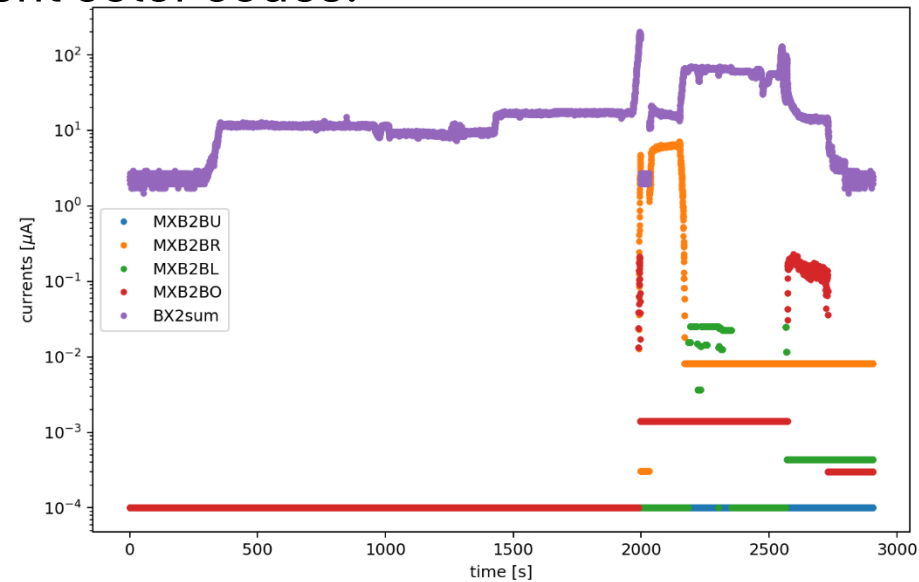
Aug 14, 2024, MBX2B

- Injector 2 setup data, beam current up to 2 mA
- Lack of signal from bottom foil (U = unten)
- Strange signal from left foil

- Lack of signal from bottom foil
- Strange, low signal from left foil again

- The position interlock must be bridged!
- We have spare for this blende
- Status of MXB2A? No signals observed last week, but there are some in DB.

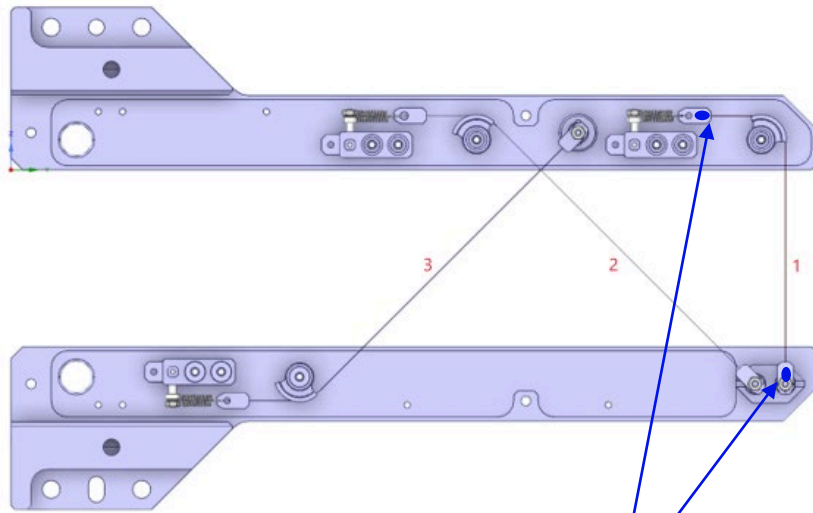
For 2 years we had issues with breaking RRL wires.

Now it seems that we have found a right way of attaching and protecting the wires.

Conductive  
epoxy glue

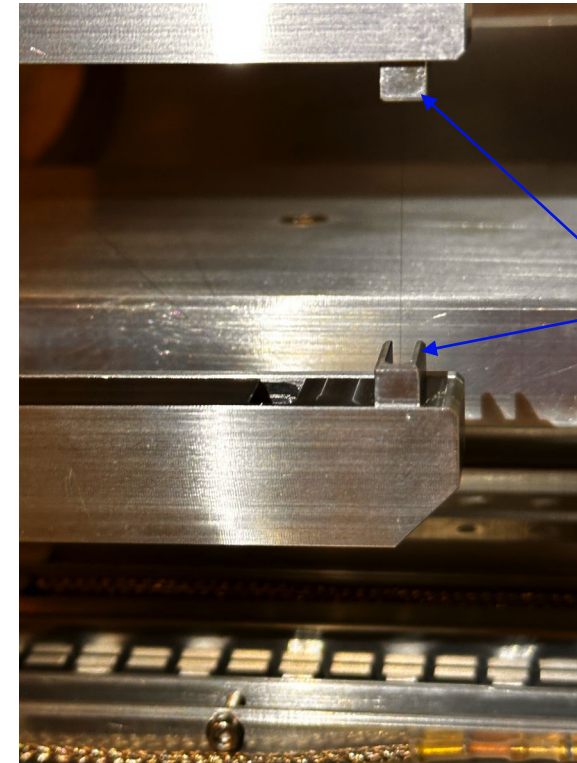
Protective  
“chimneys”

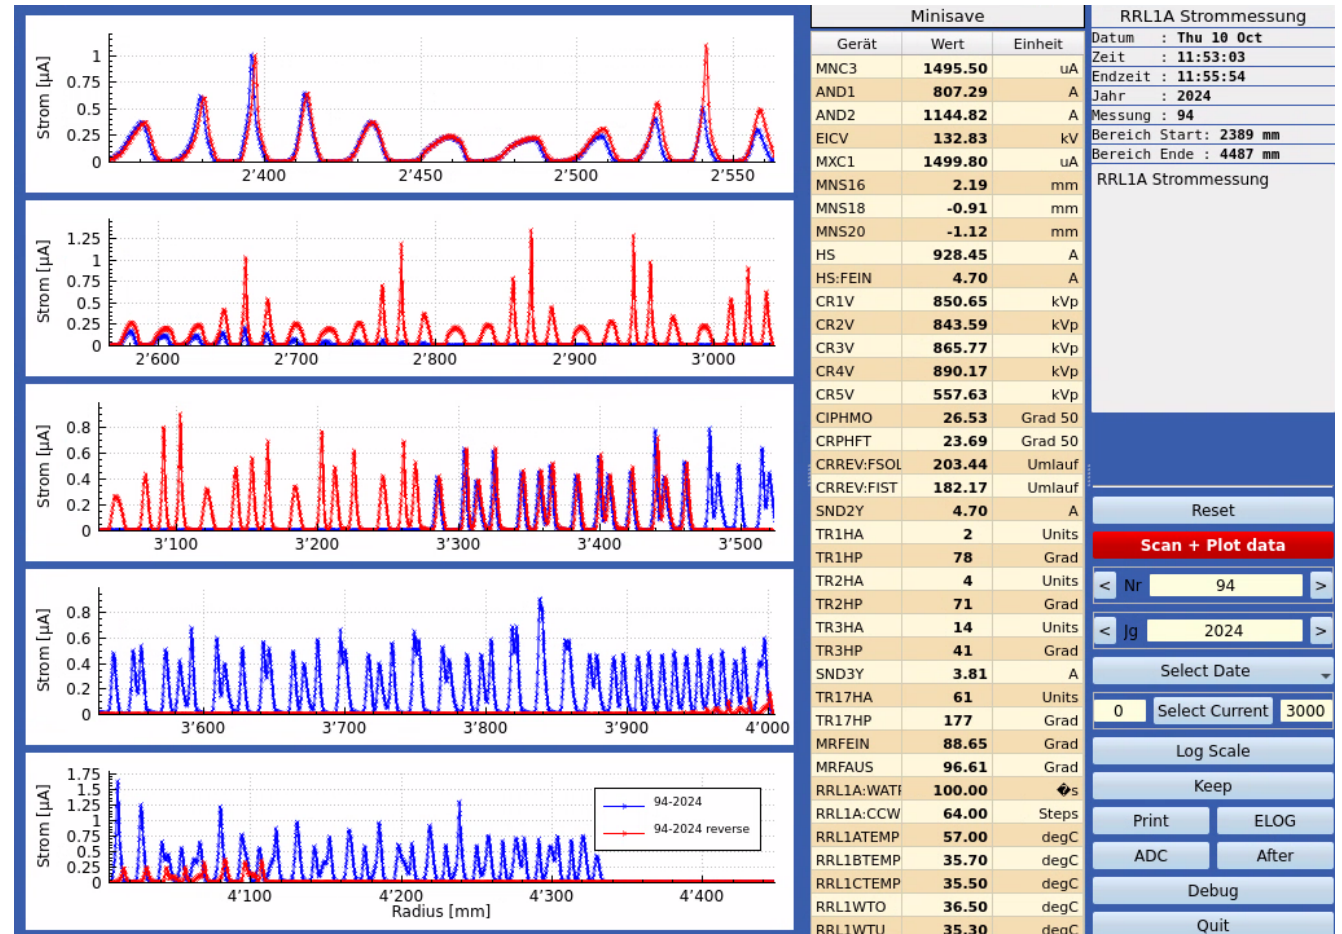
Glue and chimneys tested on October 10th.  
Several scans performed; no wire broken:
