RRL measurements on July 7th and 10th

M. Sapinski,

thanks to: S. Lindner, T. Weber, L. Fernandez
PSI, July 16th, 2025

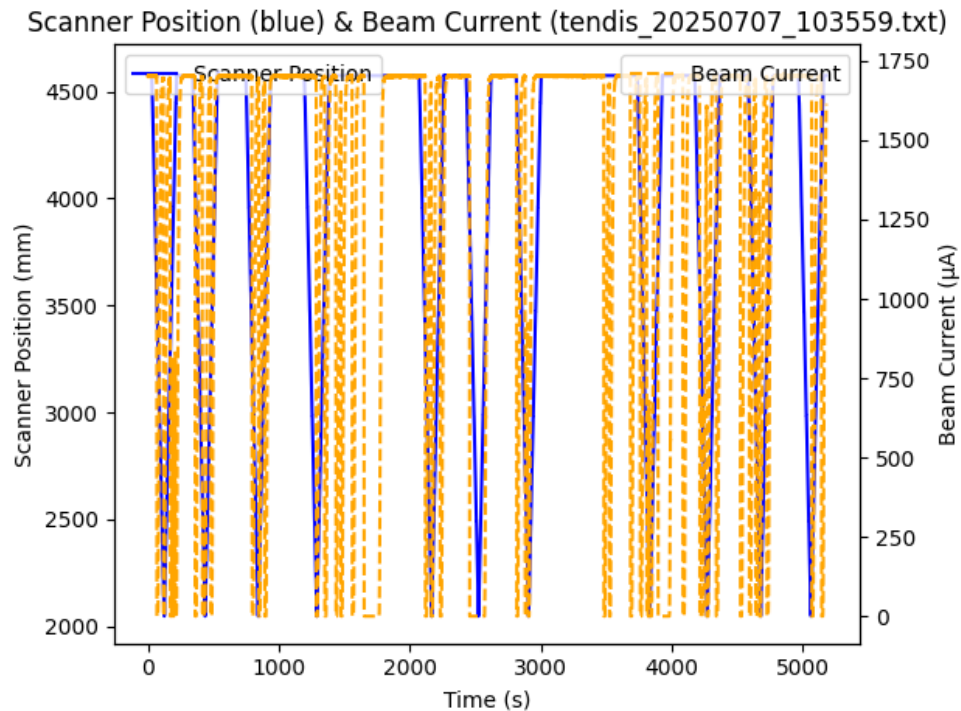
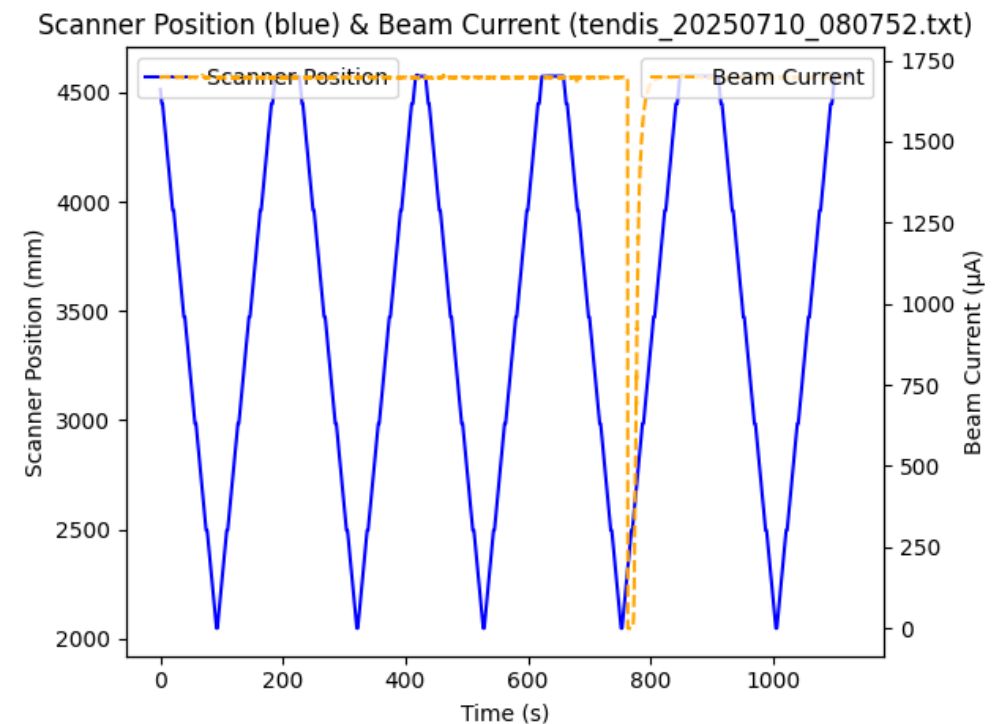
EIC interlocks

1. RRL is in proximity of injection septum, which is electrostatic element with voltage of ~ 133 kV.
2. RRL scans provoke sudden jumps in dark current \rightarrow sparks in EIC \rightarrow interlocks.
3. Interlock probability depends on the beam intensity \rightarrow tests done at 1.7 mA.
4. Before cleaning: 3 interlocks/scan (over 11 scans).
5. After cleaning: 0.2 interlocks/scan (over 5 scans).

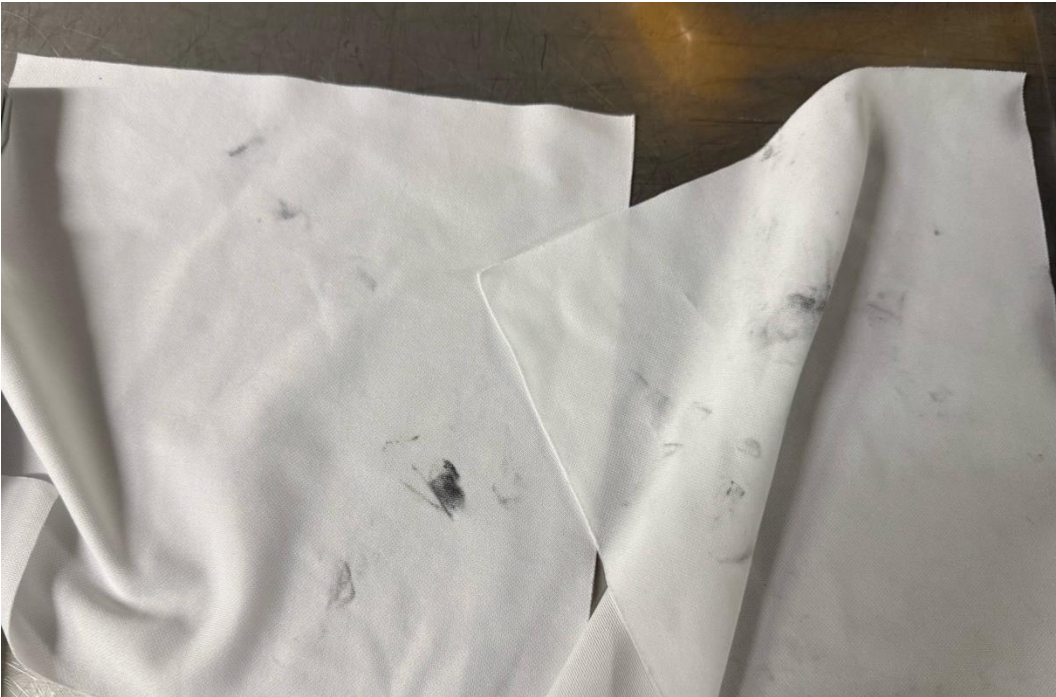
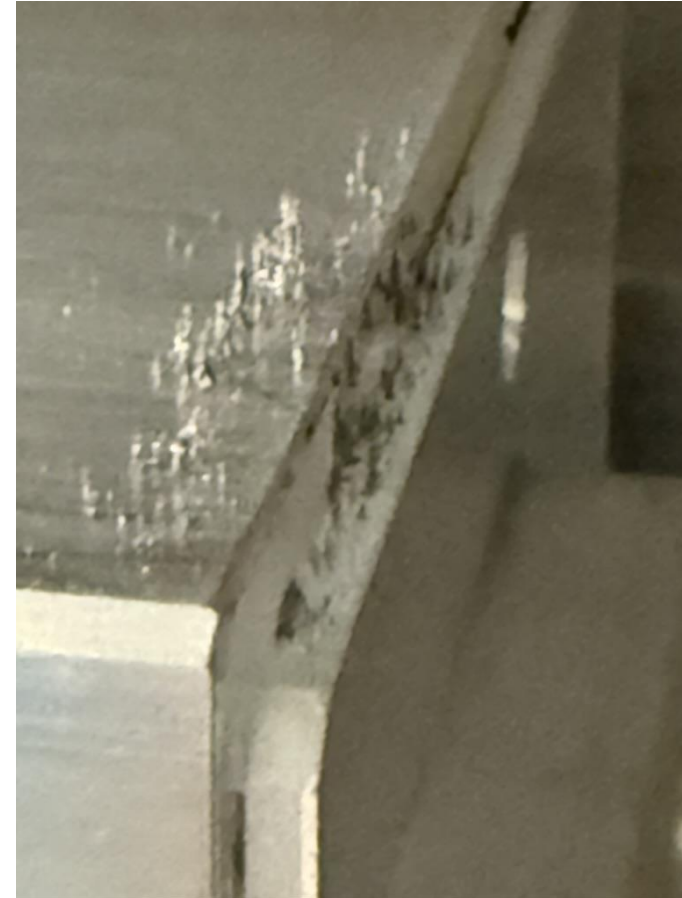
Dust collection

- The transmission belts are very difficult to clean because of a difficult access.
- We have run the scan while keeping the cleaning tissue in one location, this way accessing the whole length of the belt.
- In addition, a build up of metallic dust at the very end of RRL structure was seen and cleaned.

- It is possible to reduce EIC interlocks generated by RRL by careful cleaning and regular removal of the metallic dust.
- The dust composition suggests that it comes from stainless steel elements, most likely transmission belts.
- The cleaning procedure should be executed regularly, together with servicing the RRL wires.

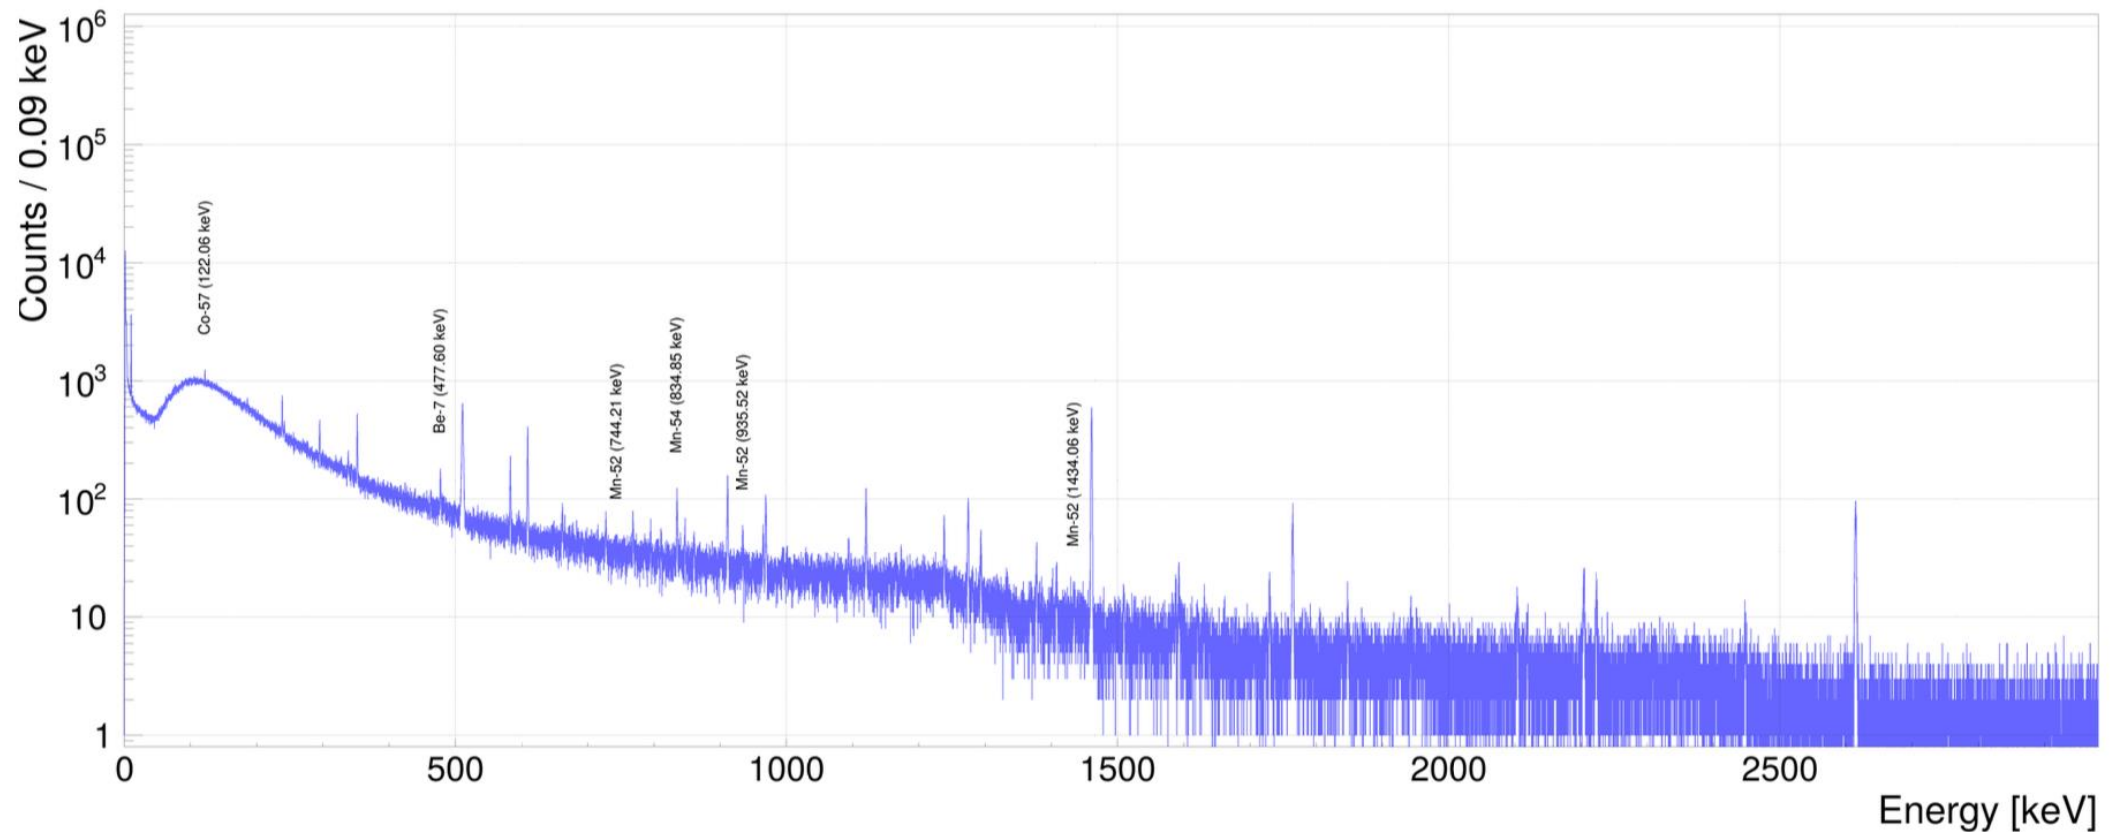
Spectrum

Gamma spectroscopy of the dust sample from belt (Marco and Dominik)

- It looks more like stainless steel (Mn-54, Mn-52, Co-57), NOT aluminum (lack of Na-22, Na-24).
- RRL transmission belt is made of stainless steel.
