Domaine / Field: Beam Instrument	Date: 30-8-2012	N ° EDMS / EDMS Nr.: 1239761
Requérant / Customer: M. Sapinski (BE-BI)	Liste de distribution / Distribution list: M. Sapinski

SEM observation along the C fibre and its tip morphology after the break in SPS

Samples : Sample of C wire broken in SPS

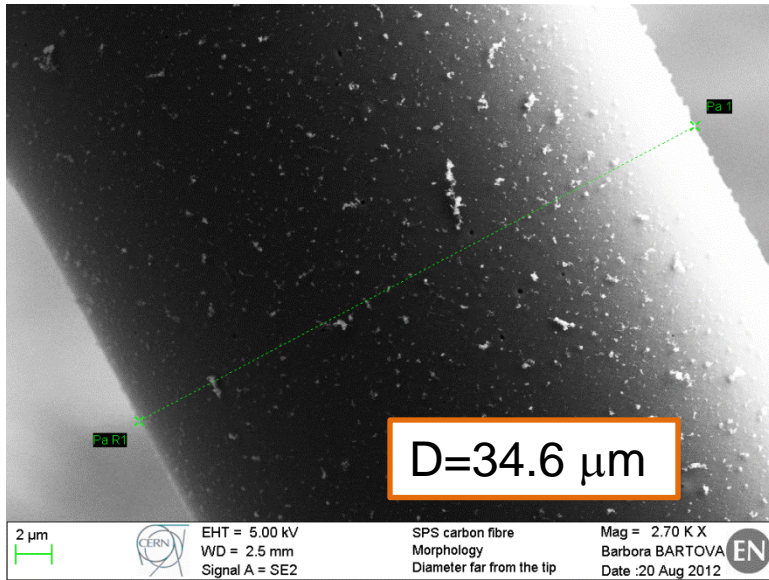
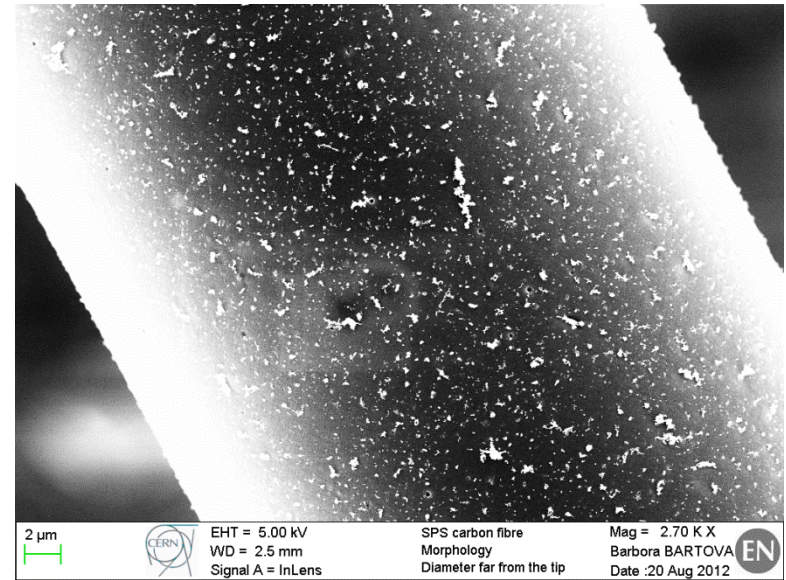
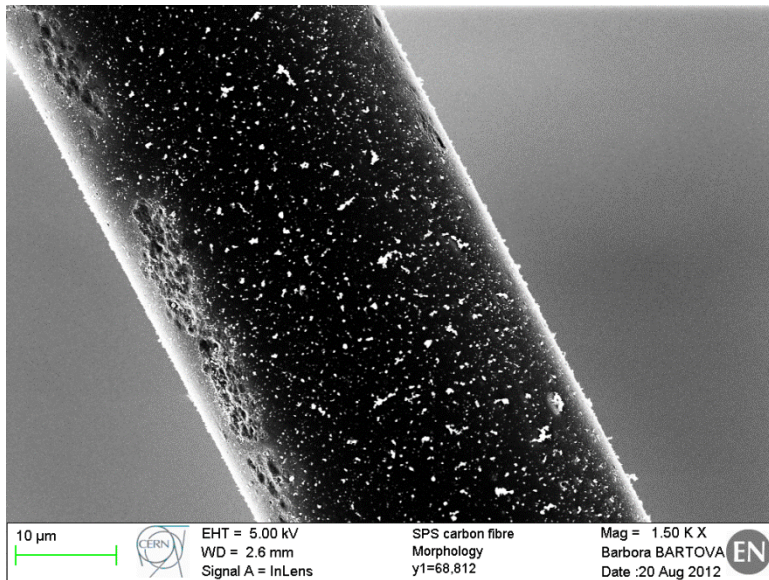
Morphology of the wire not affected with the beam

The diameter of non-damaged wire is about 34.6 microns.

Reference image with normal structure of C-wire. The goal was roughly estimate how far from the broken tip the damage could be found.

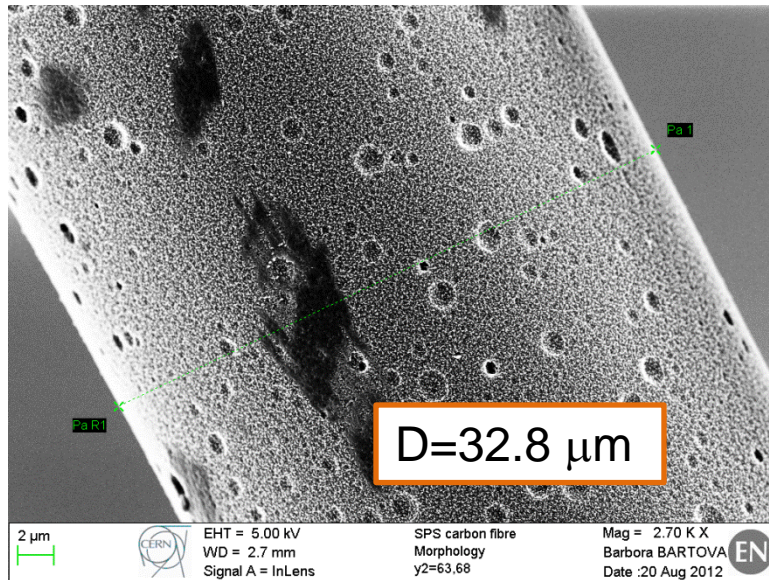
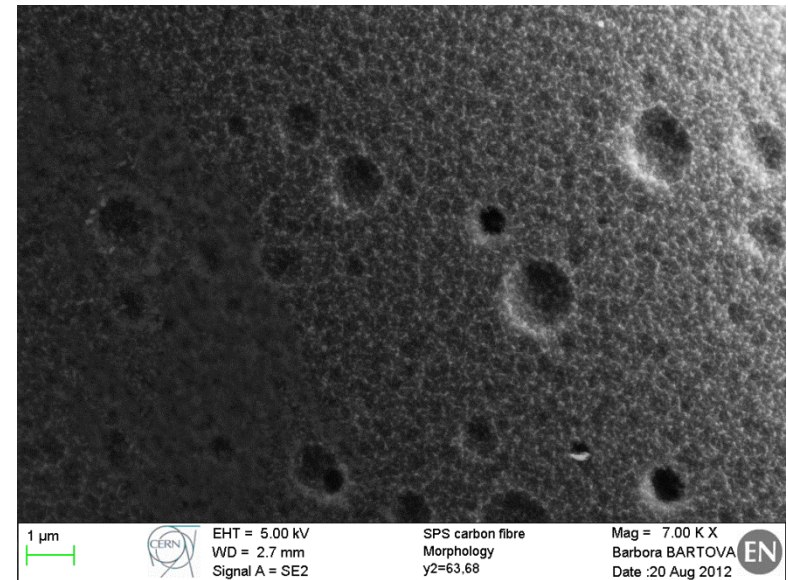
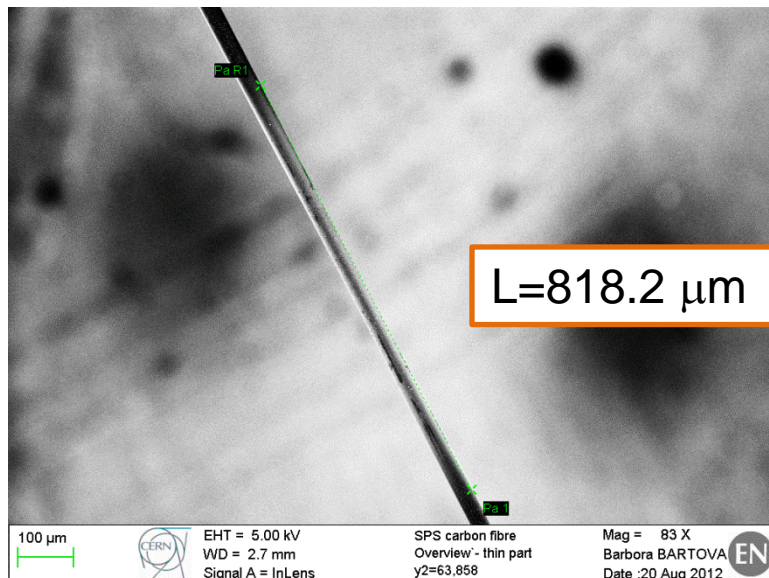
Morphology of the 1st area affected with the beam

The diameter of 1st area of the wire affected with the beam from reference point is about 32.8 microns. The length is about 820 microns. Small round hole were found on the surface of damaged area.

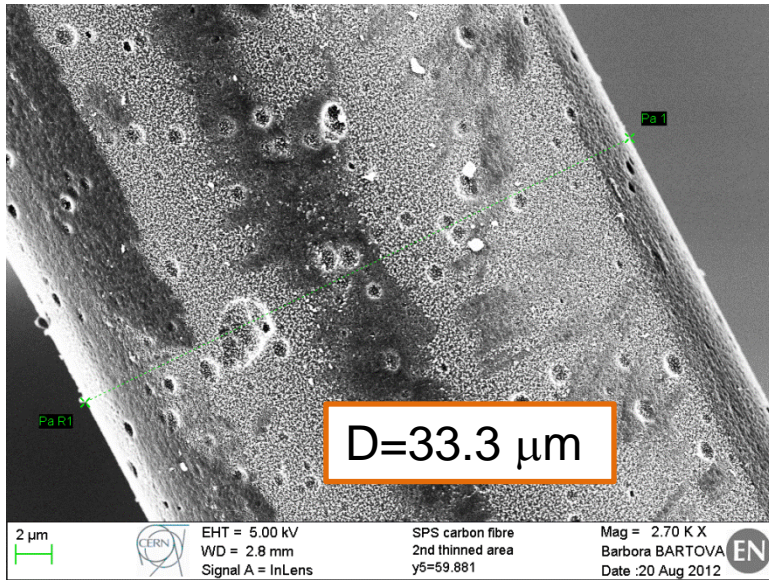
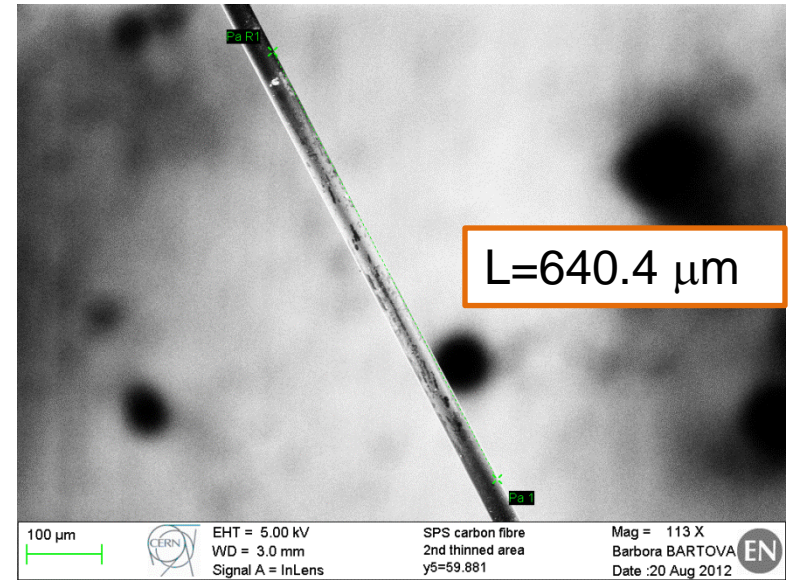
Morphology of the 2nd area affected with the beam

The diameter of 2nd area of the wire affected with the beam from reference point is about 33.3 microns. The length is about 640 microns.

Small round hole were found on the surface of damaged area.

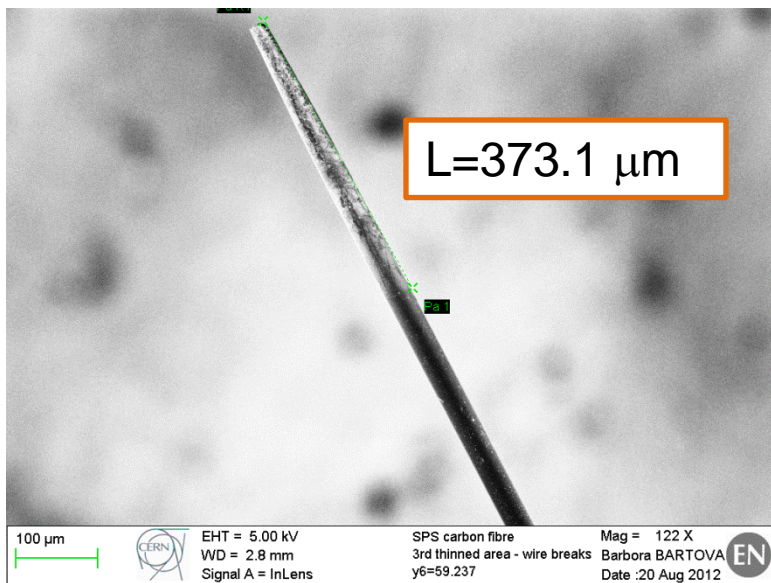
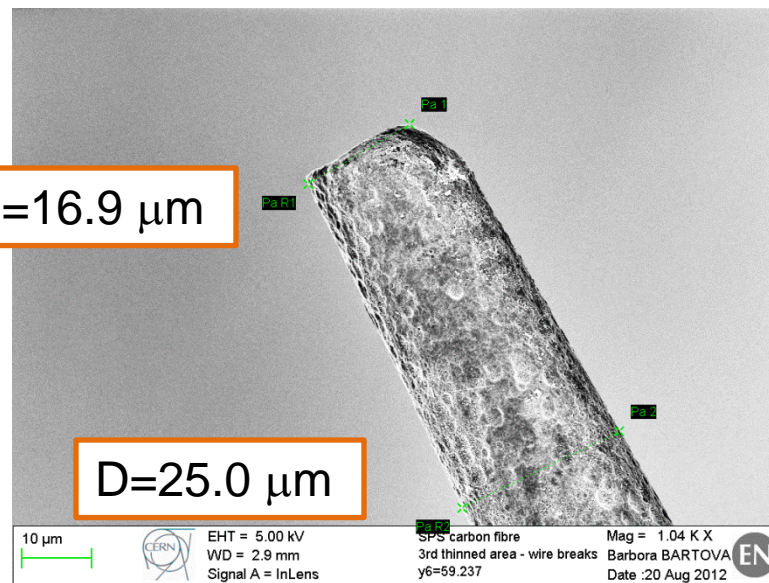
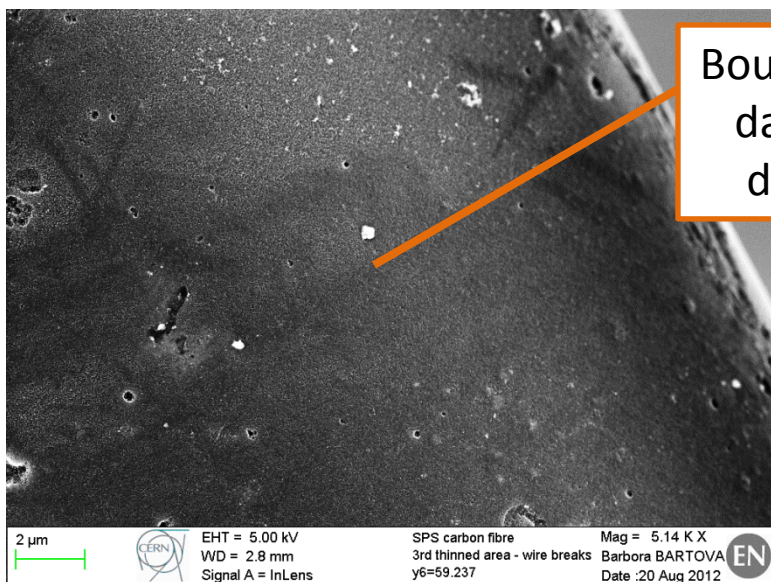
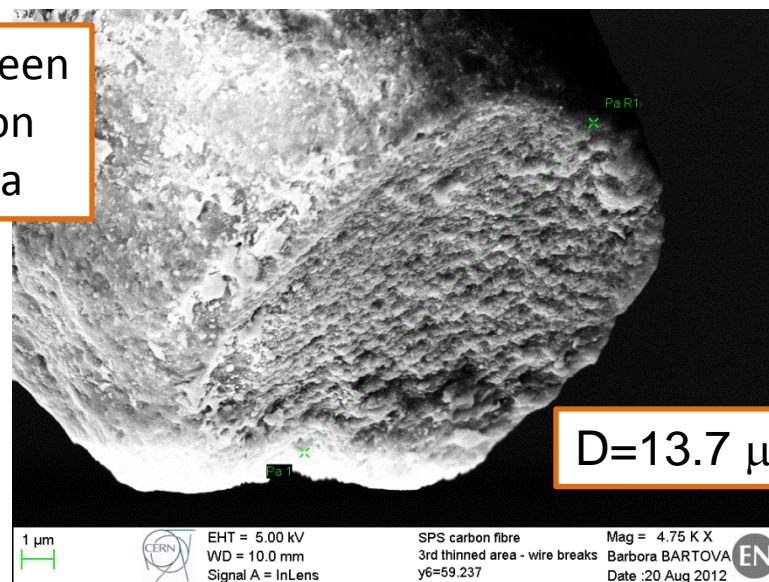
Morphology of the 3rd area affected with the beam – wire breaks

The tip of the C - wire broken in SPS was studied in detail. The cross section C – wire diameter is 13.7 microns almost 1/3 of original diameter of 34.6 microns. The morphology of the damaged areas shows holes on the surface and roughness. There are 2 other areas apart from the tip that were damaged, the first one is 644 microns far from the tip, the second one 4 mm far from the first one. Mentioned effect corresponds to the alignment of the beam during the experiment. EDS analysis revealed that particles on the surface of the wire corresponds to mixture of C,Si,Al and O.

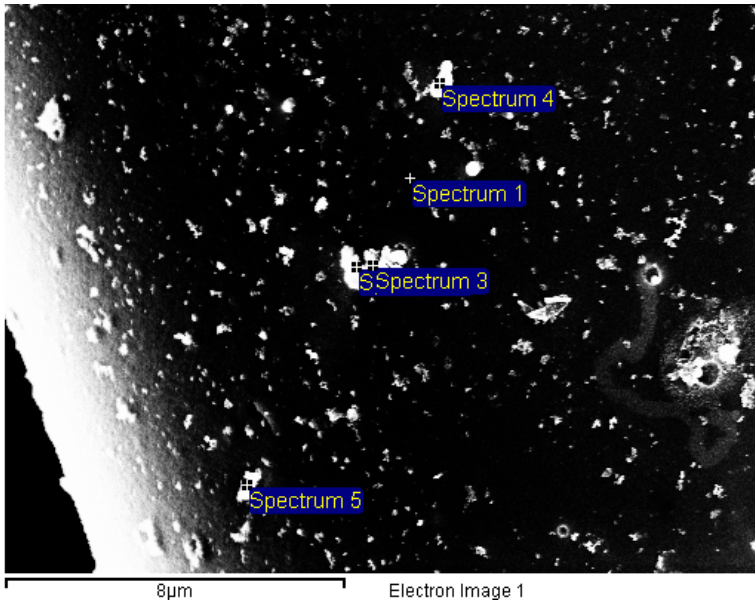
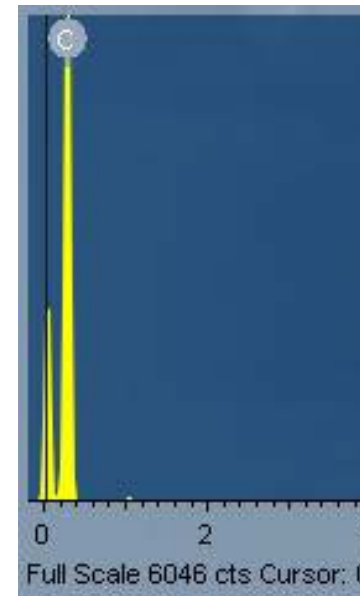
Spectra from C wire

Spectrum	In stats.	C	O	Al	Si
Spectrum 1	Yes	99.49	0.40	0.00	0.11
Spectrum 2	Yes	75.98	19.10	0.86	4.06
Spectrum 3	Yes	97.10	2.18	0.17	0.56
Spectrum 4	Yes	70.47	29.21	0.31	0.00
Spectrum 5	Yes	87.11	5.16	6.02	1.70
Mean		86.03	11.21	1.47	1.29
Std. deviation		12.73	12.46	2.56	1.69
Max.		99.49	29.21	6.02	4.06
Min.		70.47	0.40	0.00	0.00
