**EN-MME/MM**Section de Matériaux et Métrologie/ *Materials and Metrology section***Rapport expérimental / Investigation report**

Domaine / Field: SPS	Date: 2-02-2012	N° EDMS / EDMS Nr.: 1183817
Requérant / Customer: M. G. Sapinski (BE/BI)	Liste de distribution / Distribution list: J. Emery; A. Guerrero; M. Scheubel

SEM examination of a fractured carbon wire (2 pieces) after lead ion beam radiation in SPS

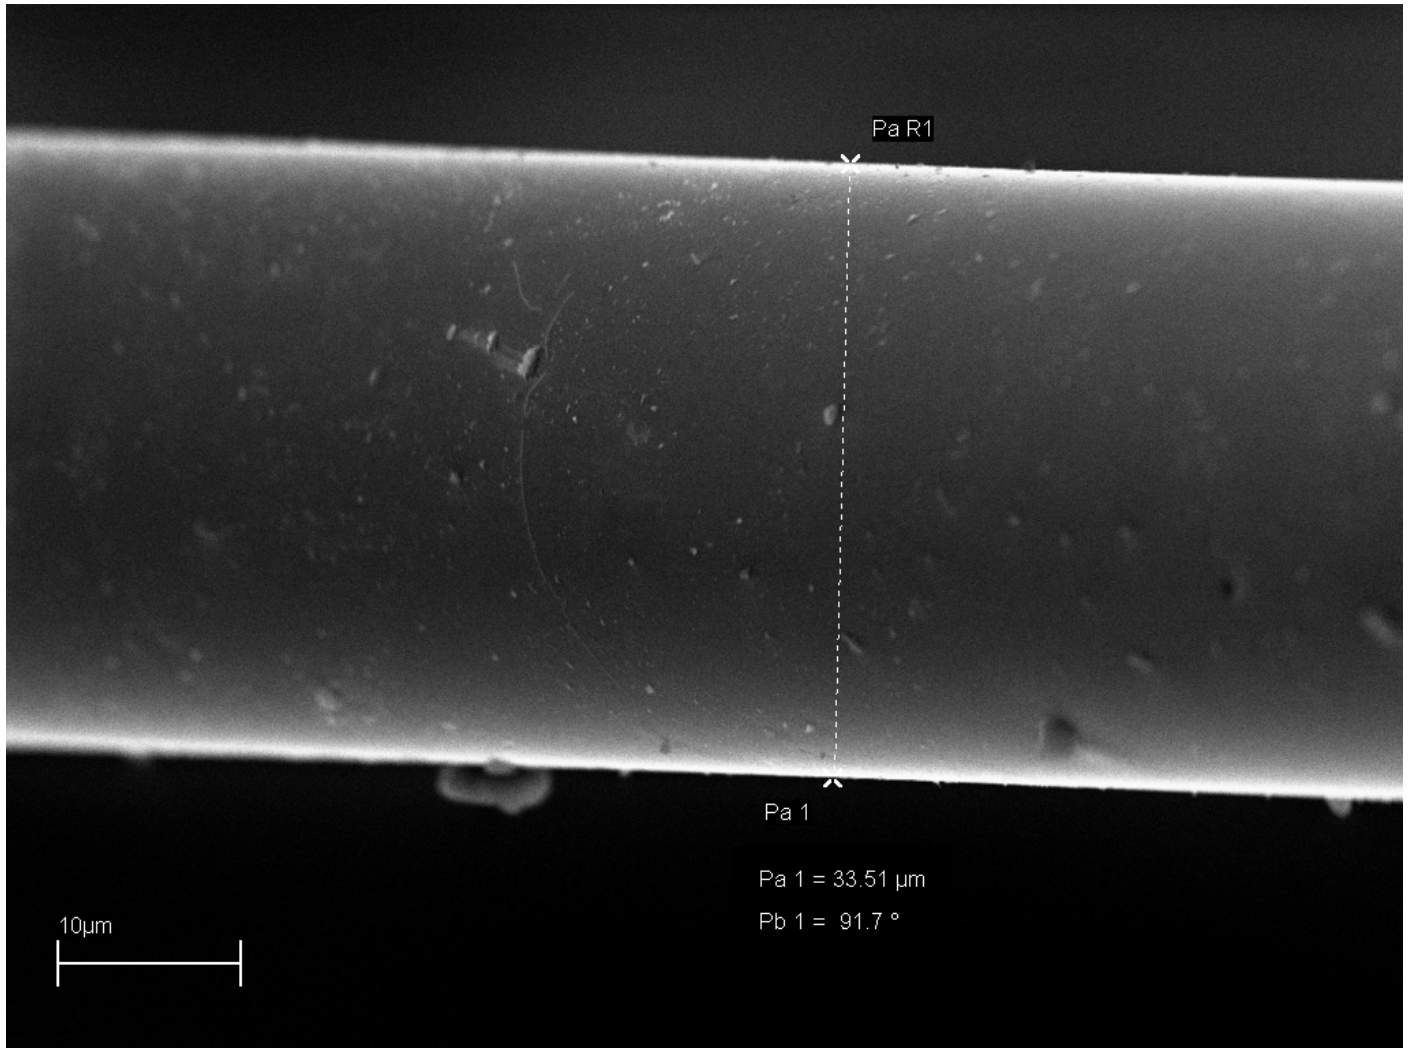
[Annex 1](#): SEM image of normal area (unaffected by ion beam exposition) with diameter of approx. 33.5 μm

Figure 1. Carbon wire – normal area (unaffected by ion beam)

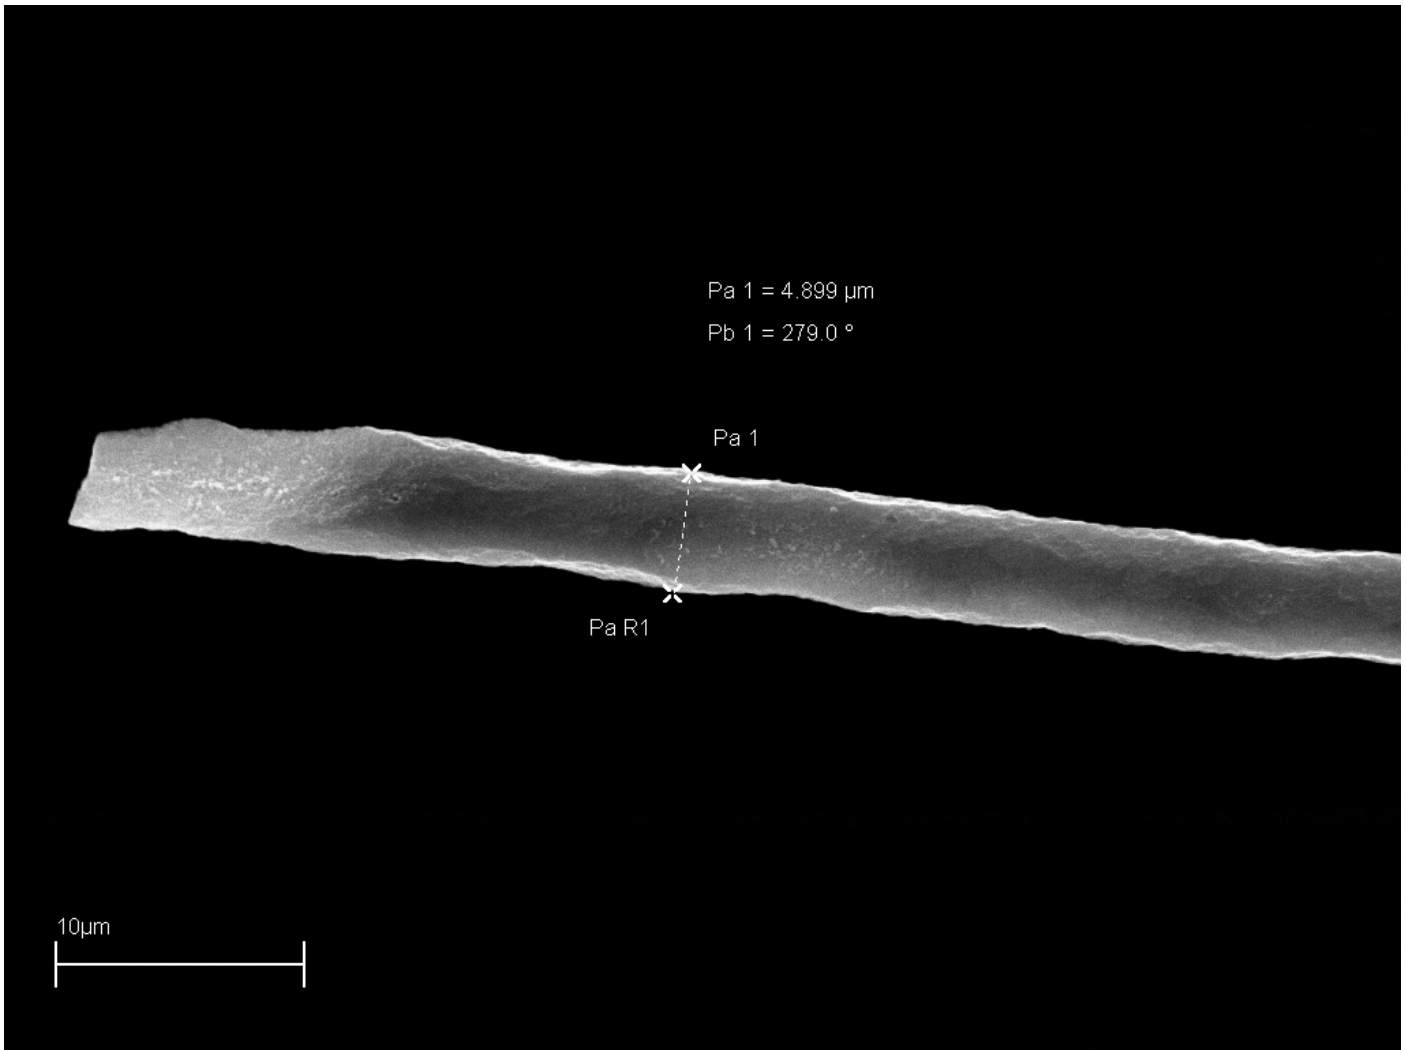
[Annex 2](#): SEM image of reduced section of piece 1 with diameter of approx. 4.9 μm

The investigation showed that ion beam caused around 95 – 97 % sublimation of the material which is comparable with the same analysis of carbon wire subjected to proton beam in SPS (ref. 3.). The wire showed brittle mechanical fracture due to dismantling. EDS analysis showed very small content of sulfur on the carbon wire.

Figure 2. Reduced area of piece 1

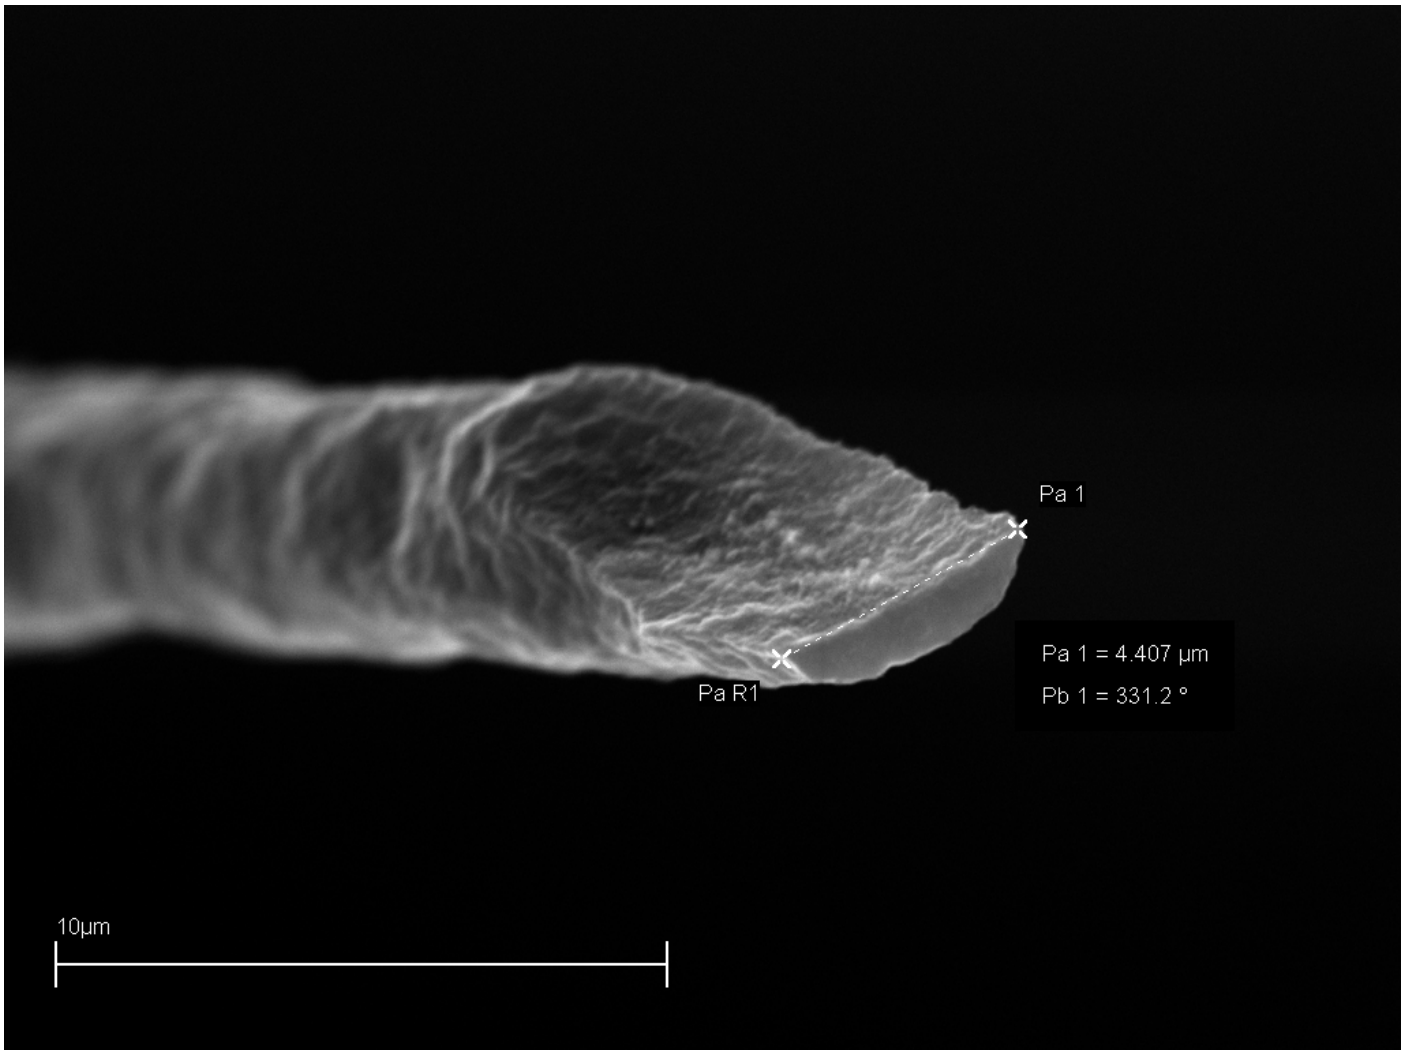
[Annex 3](#): SEM image of reduced section of piece 1 showing artificial fracture

Figure 3. Reduced area of piece 1

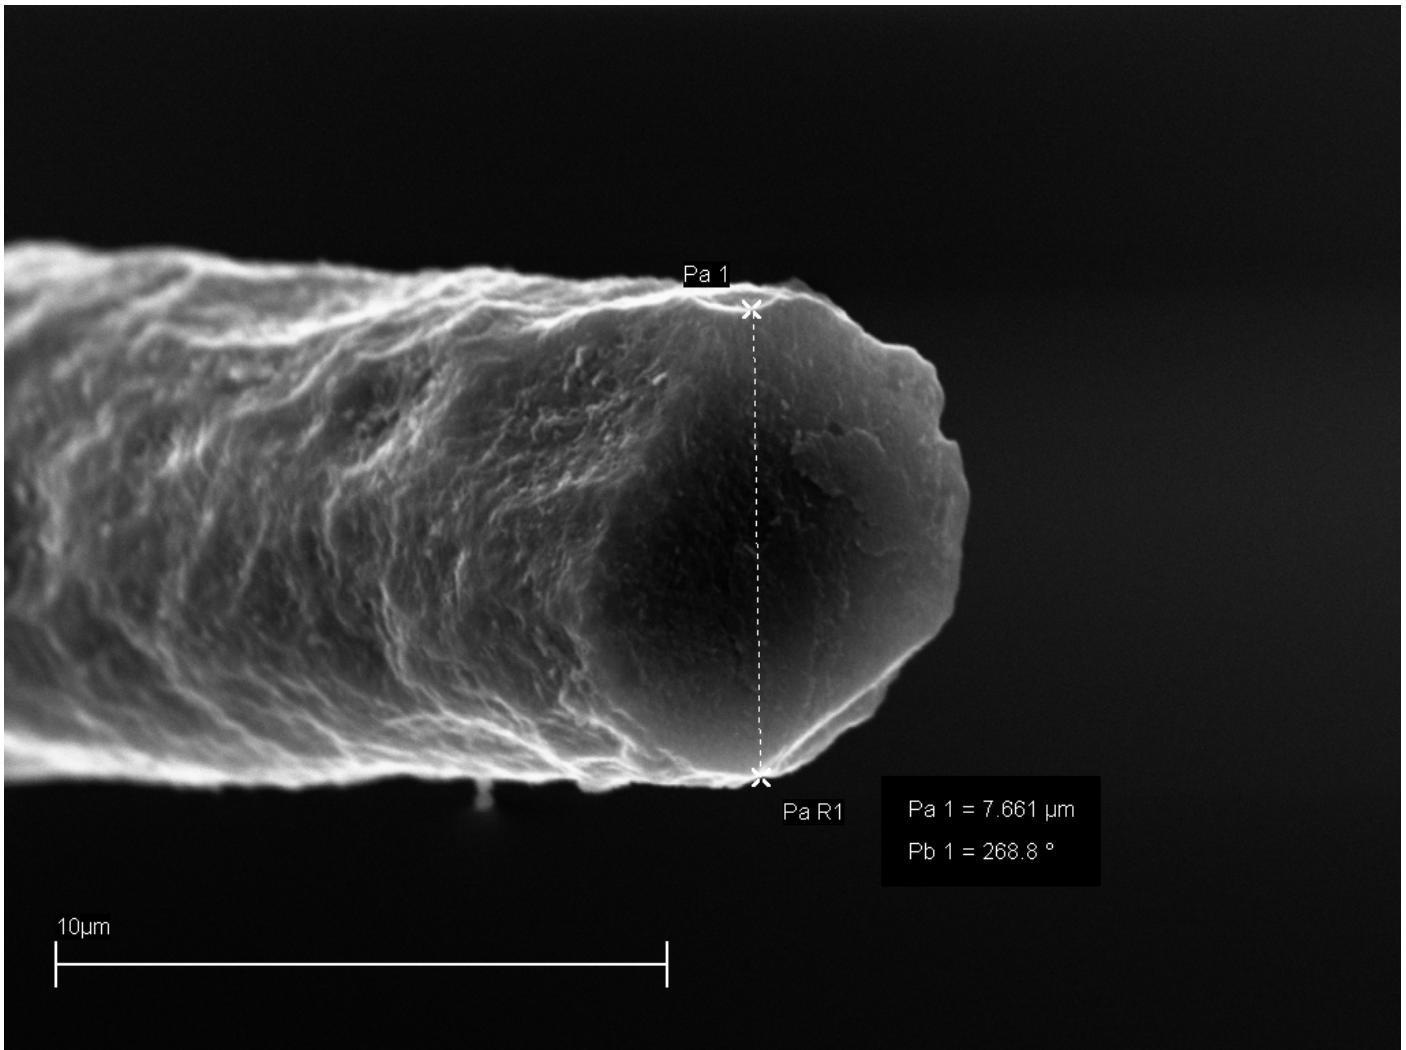
[Annex 4](#): SEM image of reduced section of piece 2 showing brittle mechanical fracture with diameter of approx 7.7 μm

Figure 4. Reduced area of piece 2

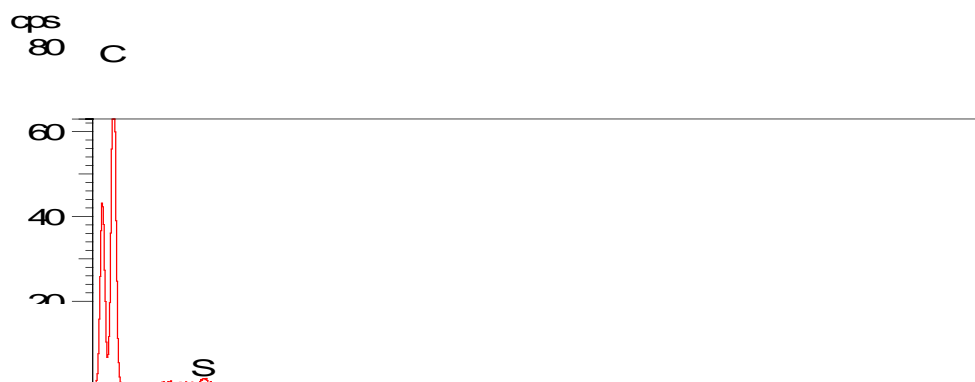
[Annex 5](#): EDS spectrum of reduced area of piece 2 (carbon and sulfur)

Figure 5. EDX spectrum of fractured carbon wire
