PAUL SCHERRER INSTITUT

Mariusz Sapinski :: Paul Scherrer Institute

RRL Strahlentwicklung results

PSI, September 19th, 2023, Strahlentwicklung Nachbesprechung

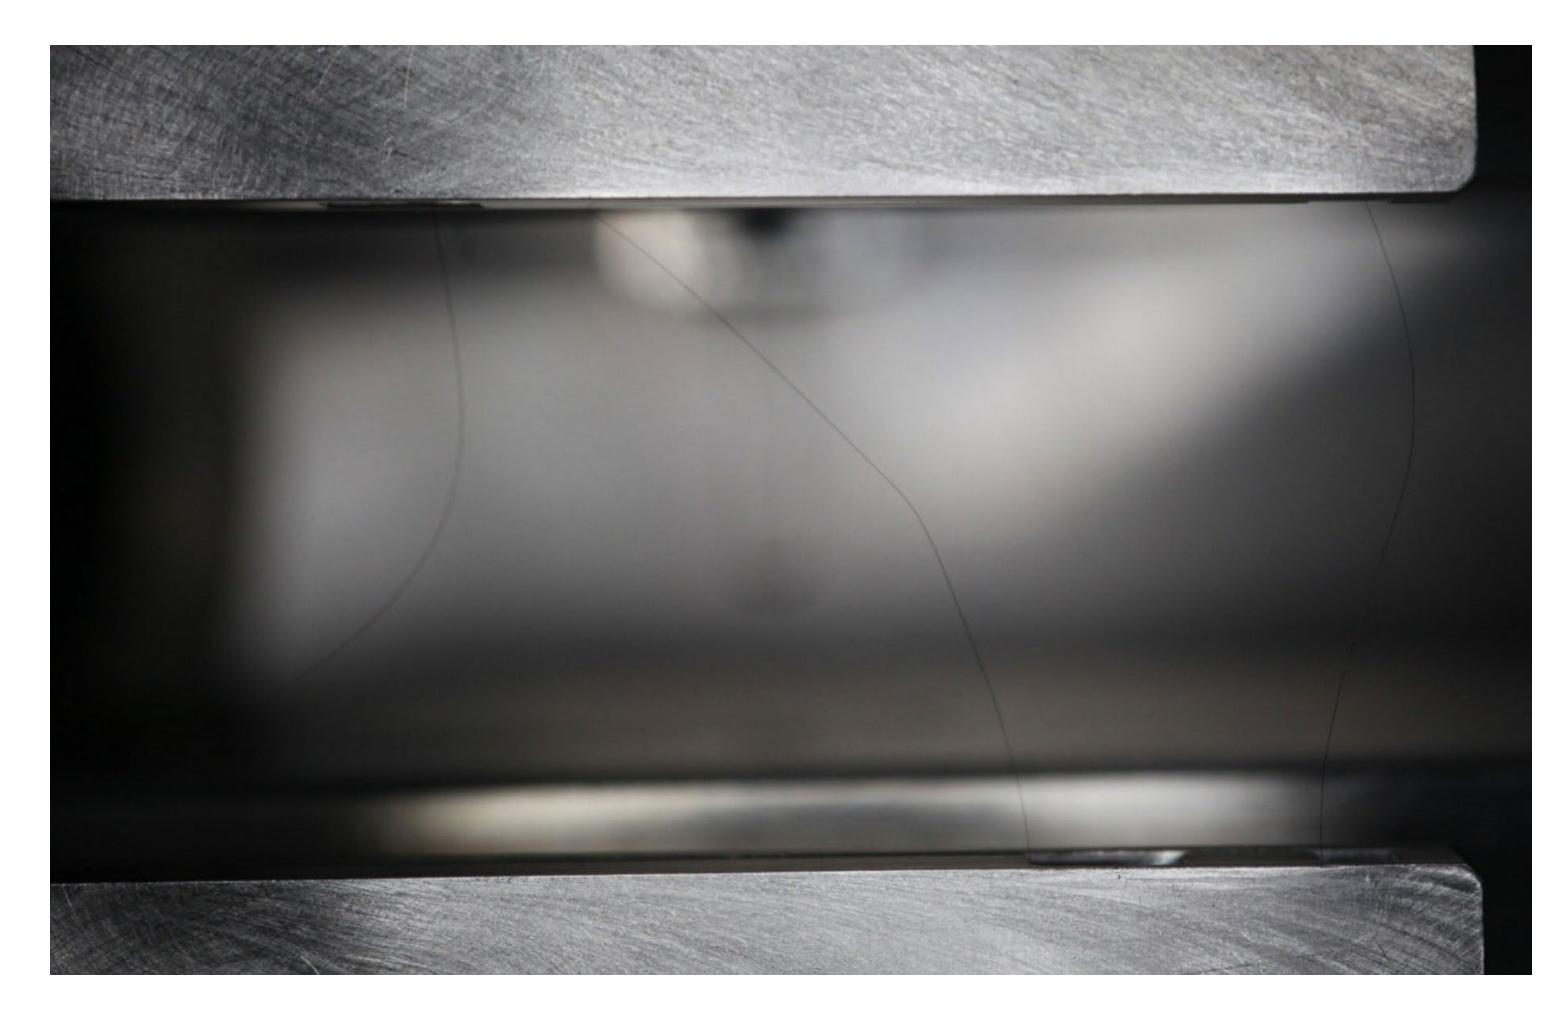
• All three wires damaged, no electrical connections but still crossing the beam:

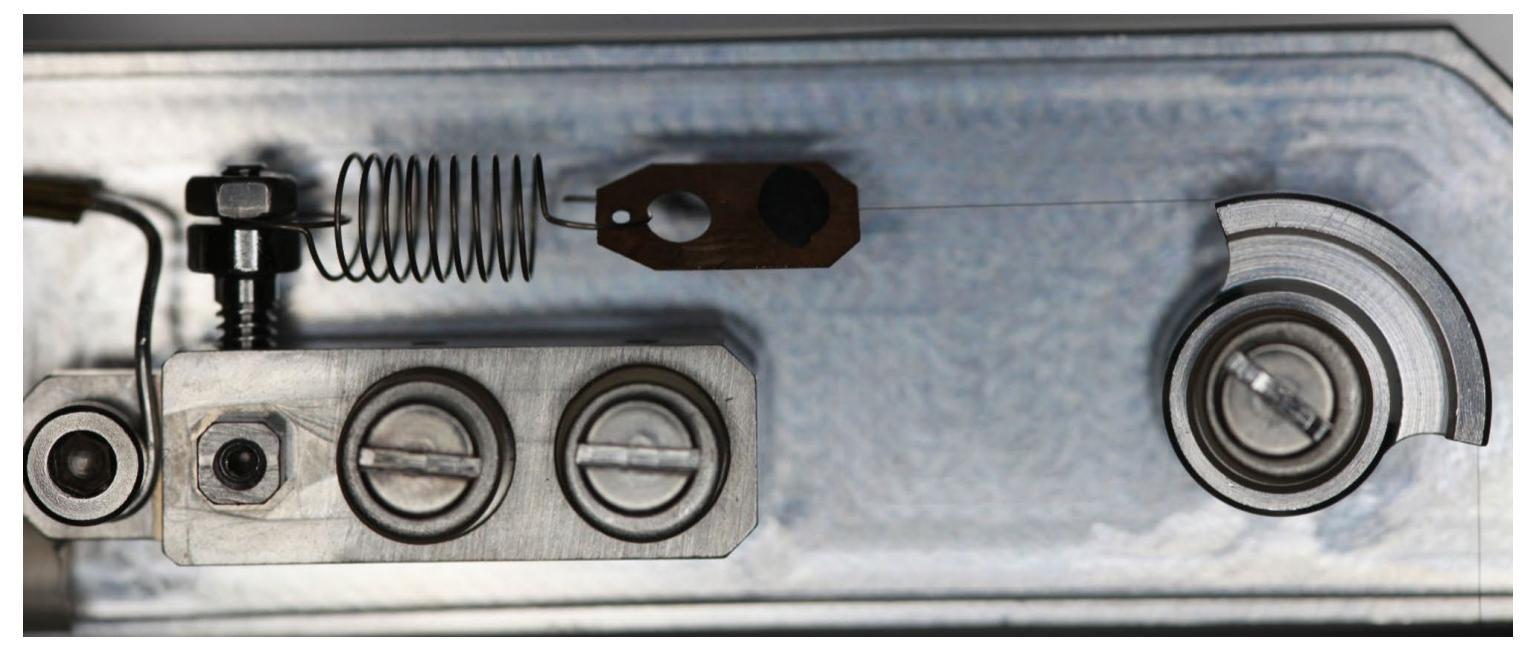
- Using 'old' wagon, with Alumina insulators (not Silica)
- actually this change has been done already in July, but during previous experiments RF was unstable and wires got broken very fast (bad luck)

Material	Thermal conductivity [W/(m*K)]	Relative permittivity (dielectric constant)
Silica (SiO2)	1.4	3.9
Alumina	12	9.1
Aluminum nitride	180	9.0

- Check the electrical connections, exchange the wires, abandon stabilizers (October)
- Install alumina nitride insulators (November)
- Install RF dampers inside the wagon (October or November)
- Find a better power supply for the ionization chamber (currently we have strong 100 Hz noise)
- (Potentially try scans with reduced Cavity 5 voltage October)

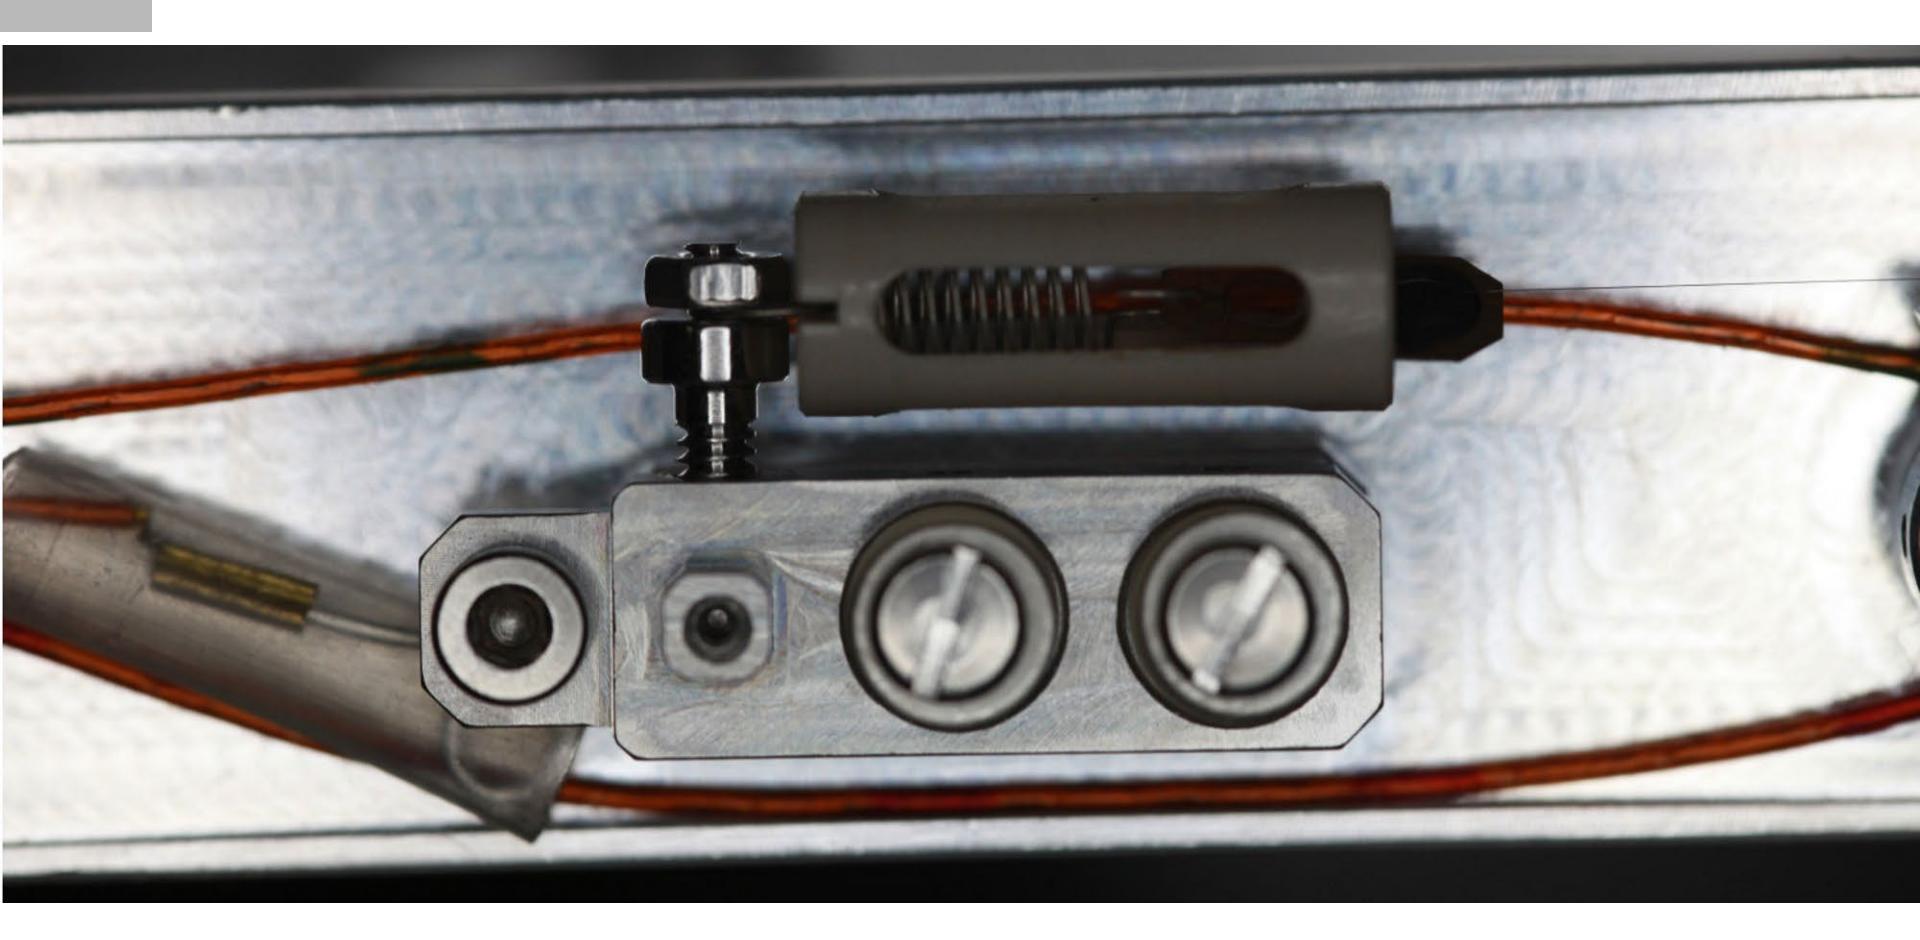
- Change of wire attachment system
- Reinstall wires
- Test spring stabilizers on wire 2,3

- Wire 2 and 3 connections on default side found to have 250 kOhm "short" to the ground
- The default side (upper) connections of wire 2,3 were removed on the wagon, readout switched to "reverse" ends (bottom).
- Wire 1 "reverse" connection was removed long time ago in an attempt to decrease RF coupling

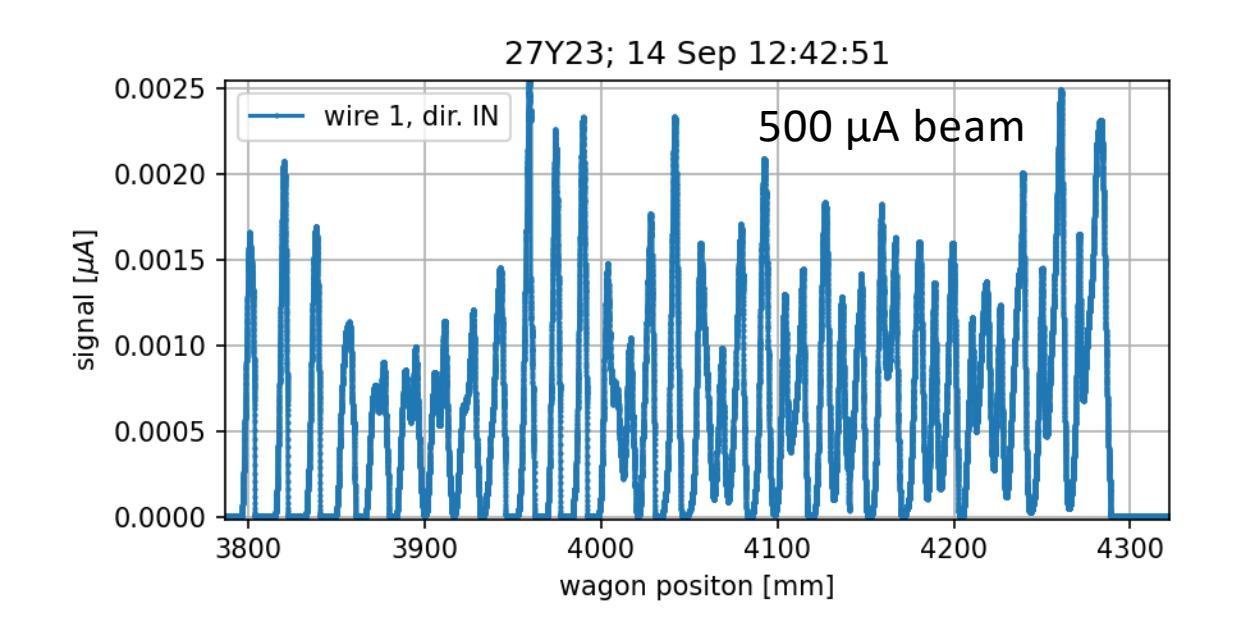
- Wire 3 no signal at all.
- Wire 2 gave some signals at the beginning, but then died
- Conclusion: "stabilizers" do not work
- Wire 1 seems to give familiar profiles finally!:

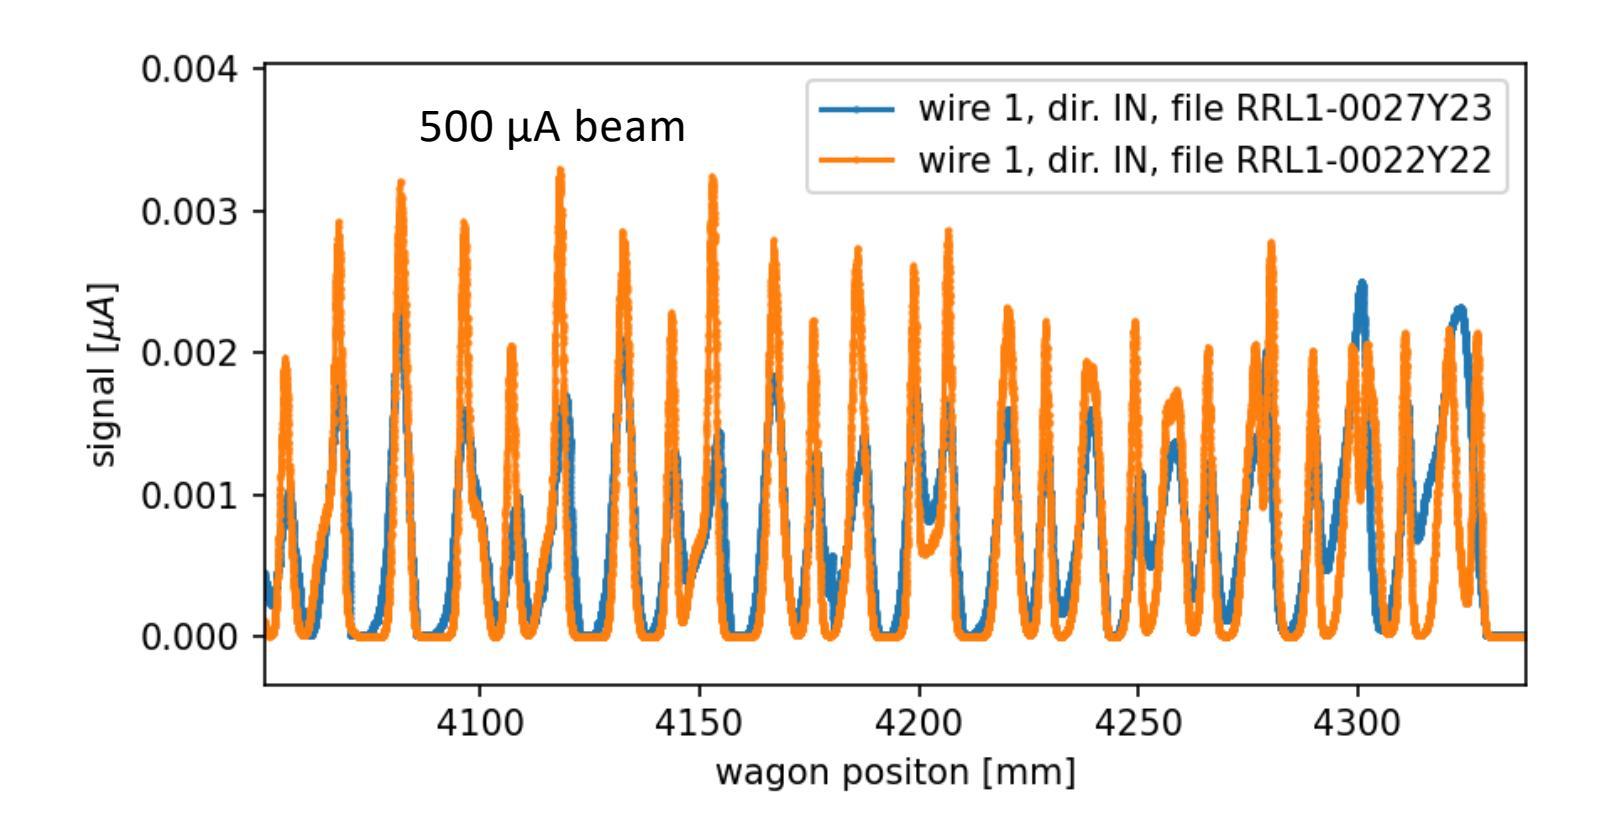
Wire 1 – compared to 2022:

- 100x smaller amplitude!
- Shift by 27Y23 by + 40 mm to overlap the results
- Signal quality is significantly worse, signal sometimes disappears when beam is still there

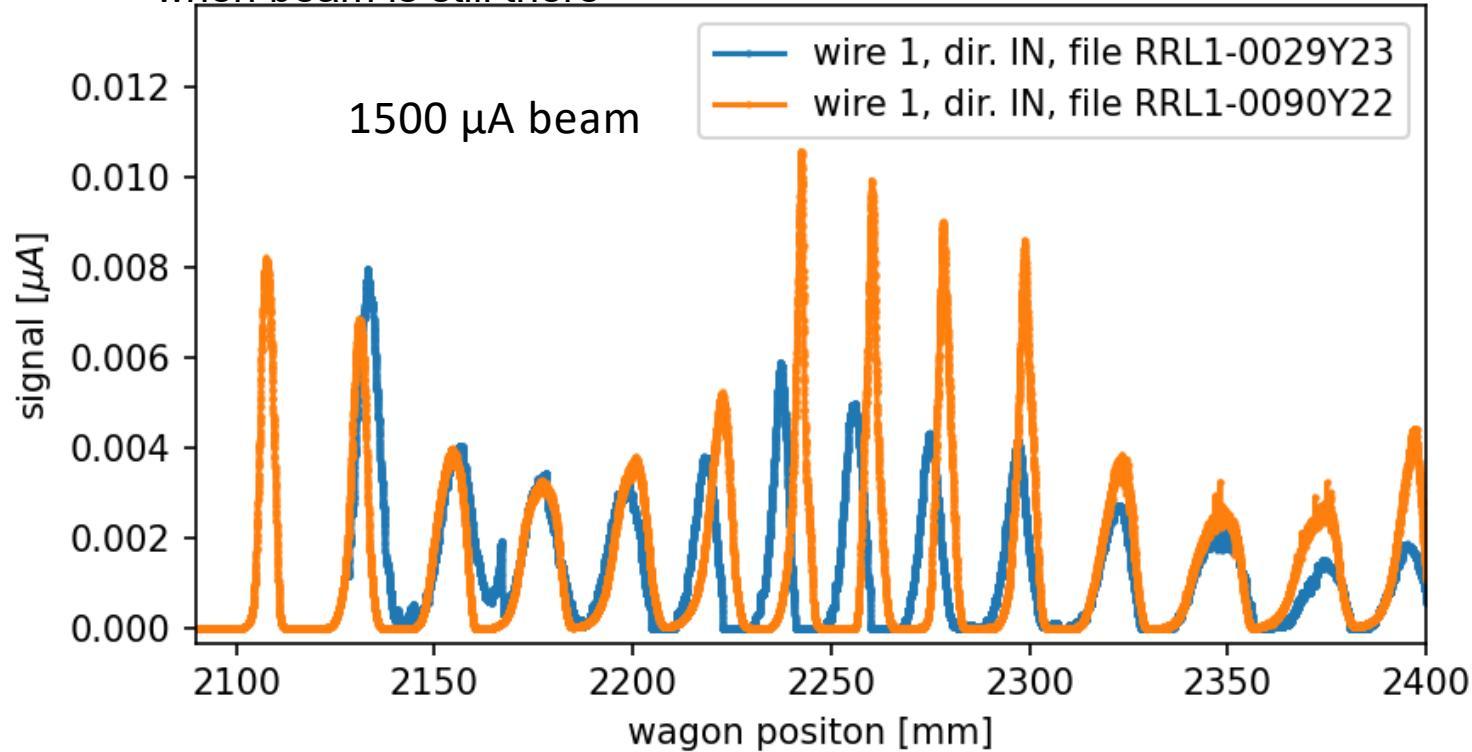
Wire 1 – compared to 2022:

- 100x smaller amplitude!
- Shift by 27Y23 by + 80 mm to overlap the results ? Is the wire already bend?
- Signal quality is significantly worse, signal sometimes disappears when beam is still there

- First time in 2023 we see wire surviving scans
- Most likely it is due to insulator made of material with better thermal conductivity (Al2O3)
 - thanks, Christian, for the suggestion!
- Unfortunately, we clearly have problem with electrical connection
- Also, the idea of spring stabilizers did not work
- U-shape target (wagon B) tested up to 600 µA, ionization chamber signal saturates to be investigated
