HEST Alignment

May 8th, 2018
m.sapinski@gsi.de

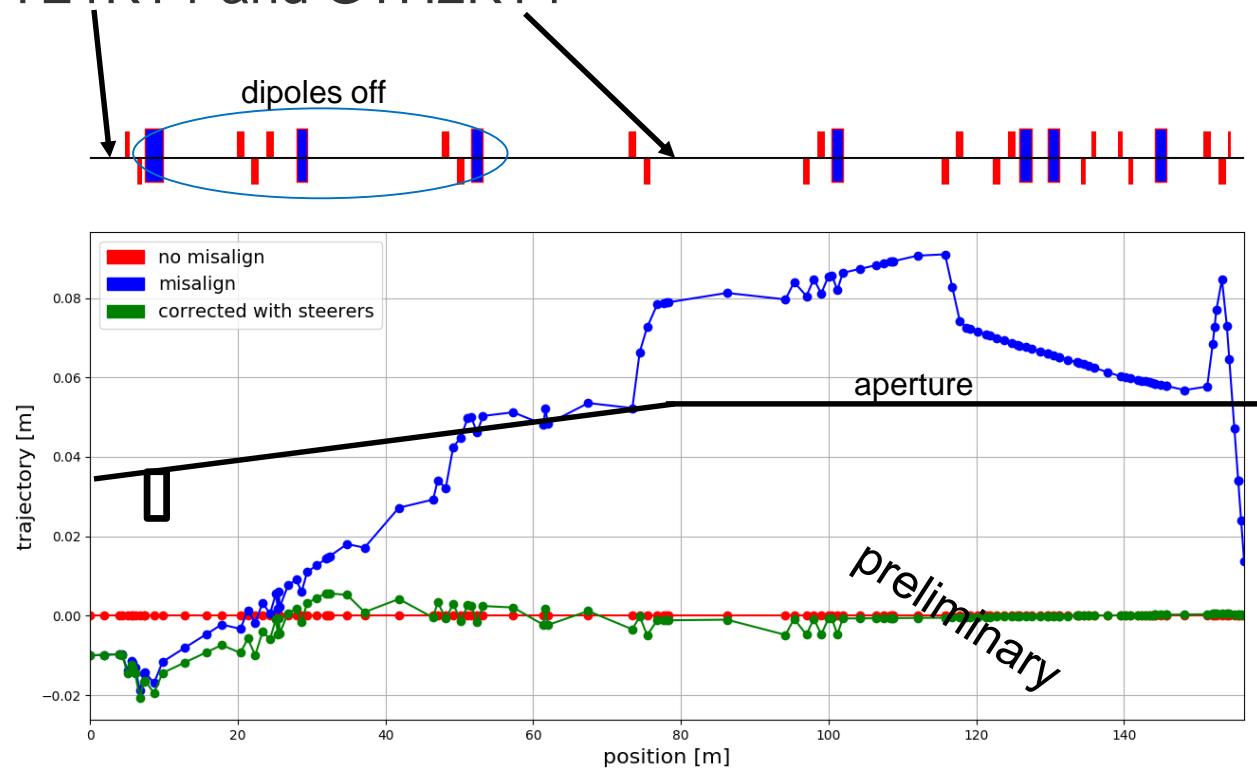
TH line – MADX correction

- based on HADES optics, using only two steerers:
GTE1KY1 and GTH2KY1

GTE1QD12: -11 mm

GTS1MU1: -10 mm, misalign = -8 mm, half-aperture = 35 mm,
expected 2 sigma beam envelope: 10 mm (MIRKO)

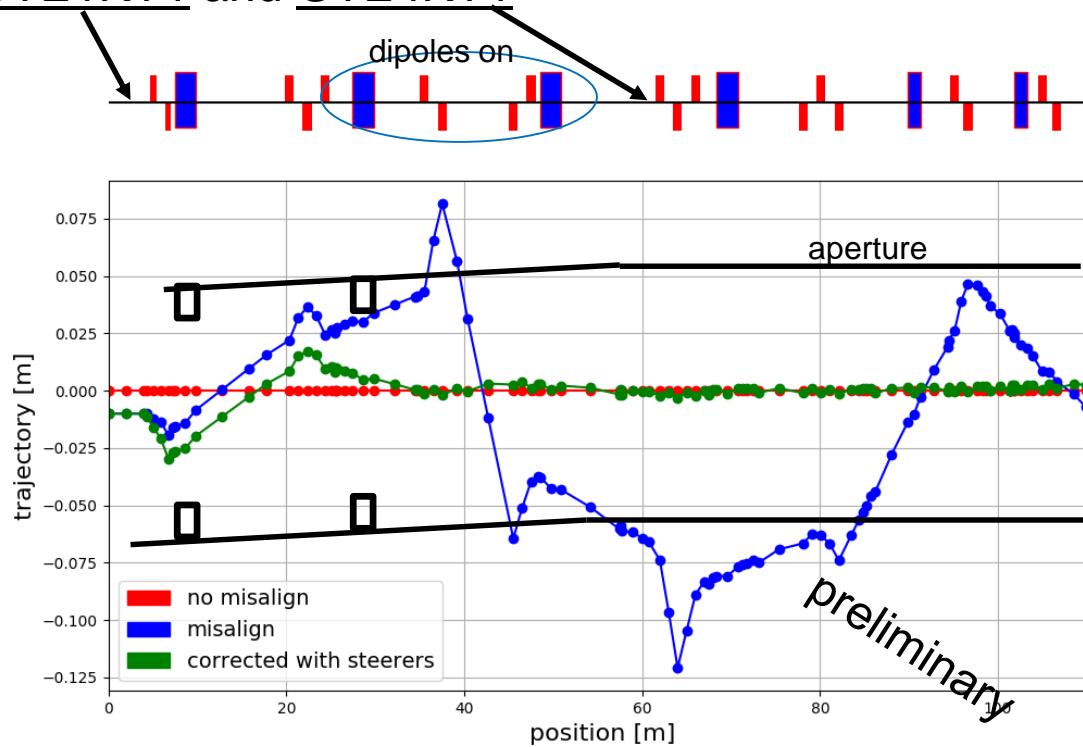
TE line – MADX correction

ESR injection optics, affected between steerers:

GTE1KY1 and GTE4KY1

MADX matching needs to adjust more magnets to achieve reasonable trajectory – to be investigated.

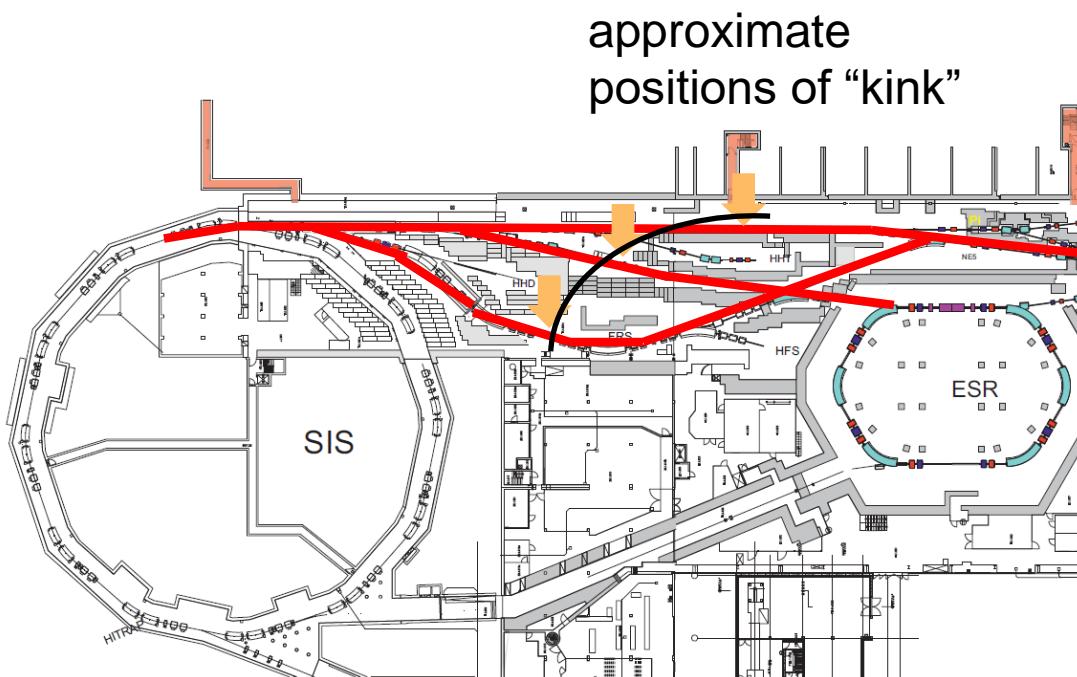
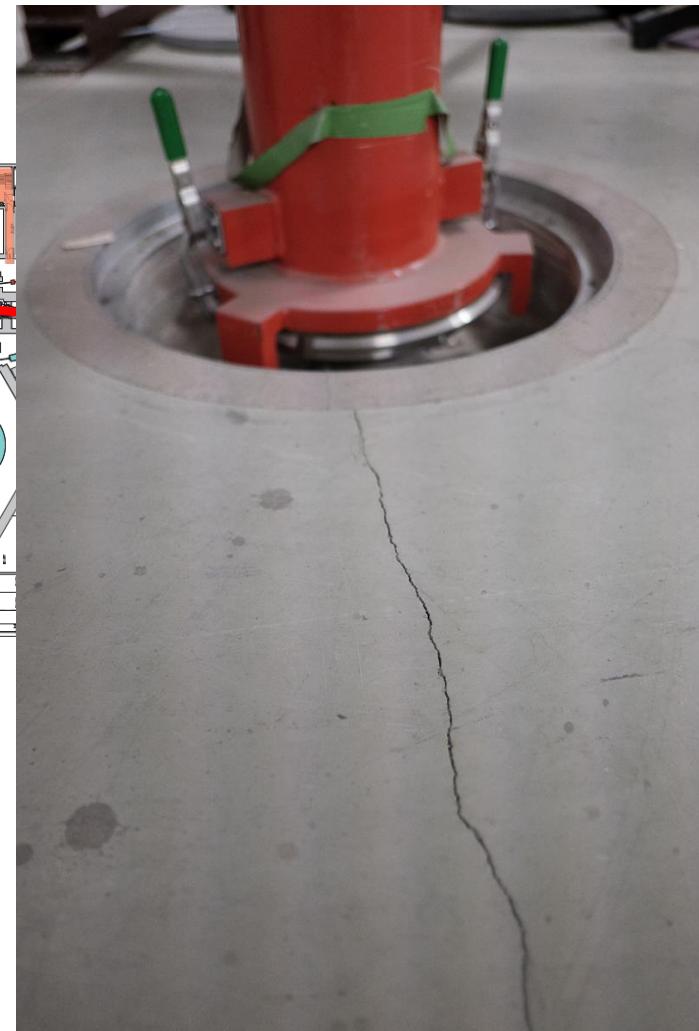
Floor cracking?

- Observation: floor maybe cracked
 - there seems to be more cracks in the “kink” zone

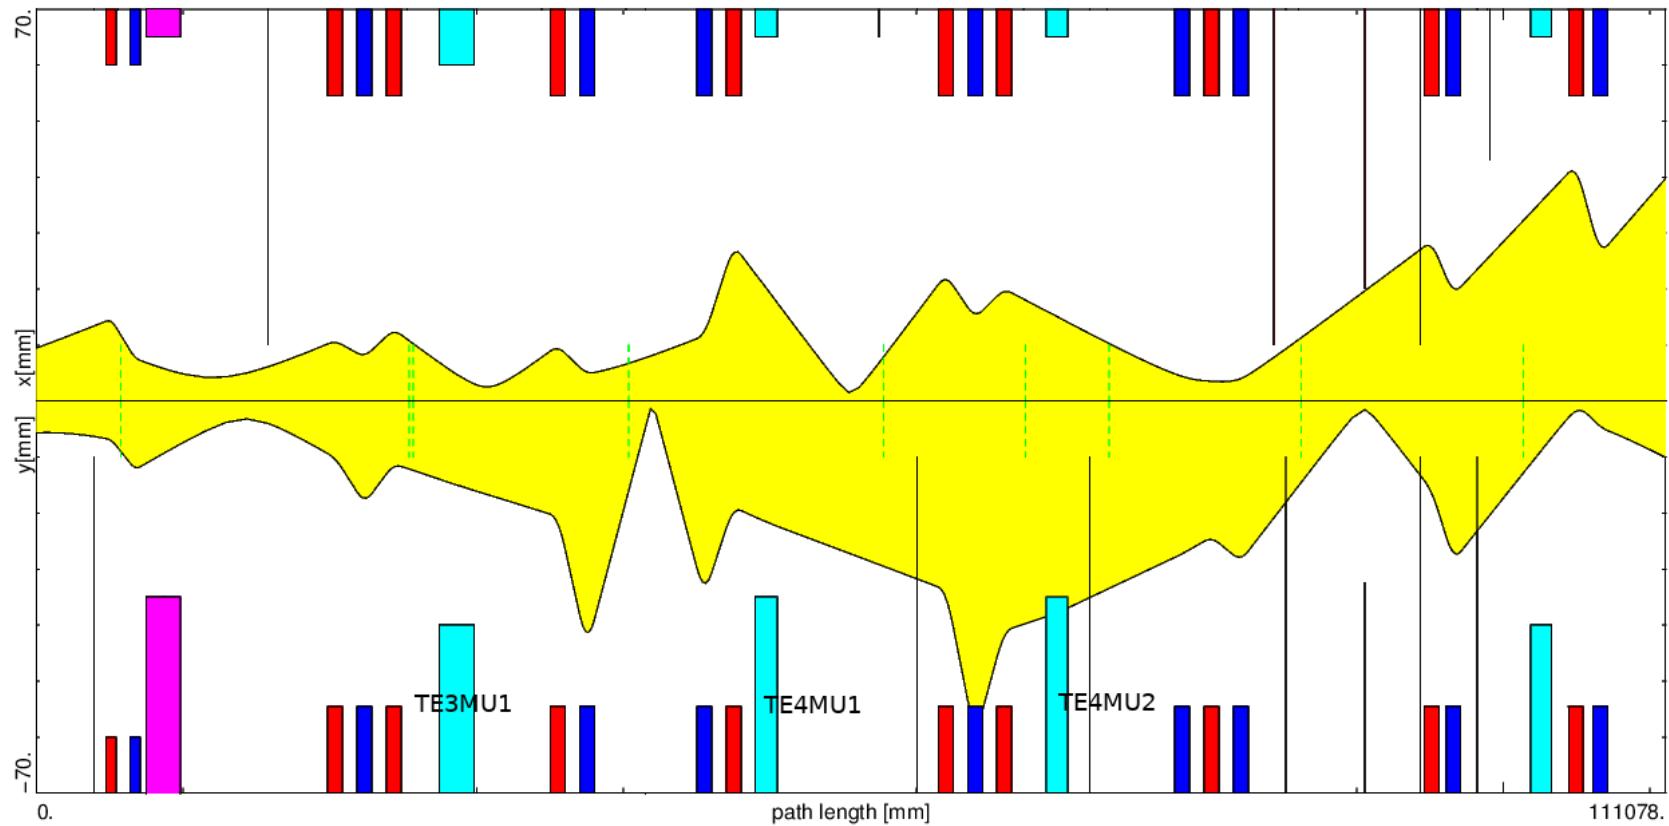
TE line – beam envelope

SE_S: 19.11.2009 – SIS bis ESR via direkt durch den Stripper
Mass= 12.0000 Charge= 6.0 Energy= 40.000 MeV/u Emittances= 5.000 5.000 pi mm*mrad
