HEST status

2018.09.25

m.sapinski

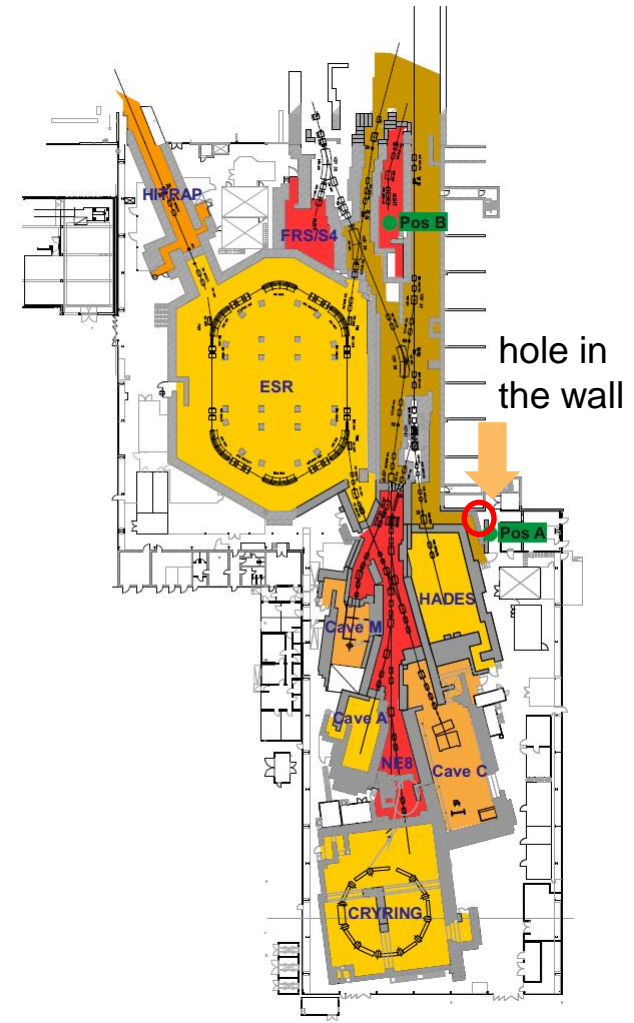
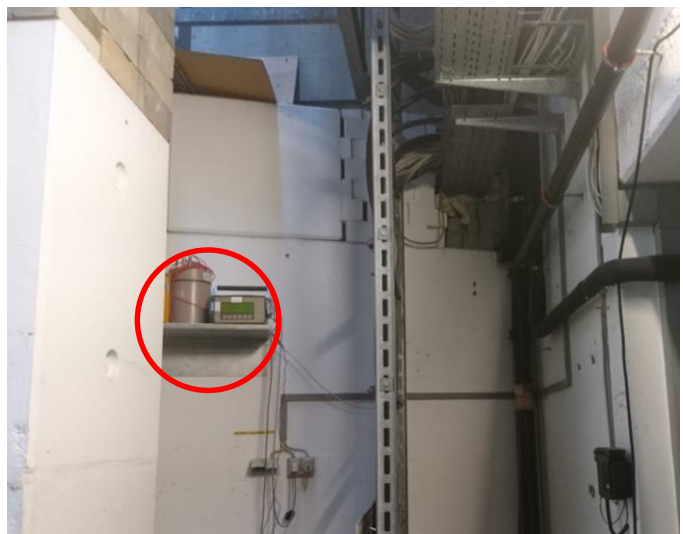
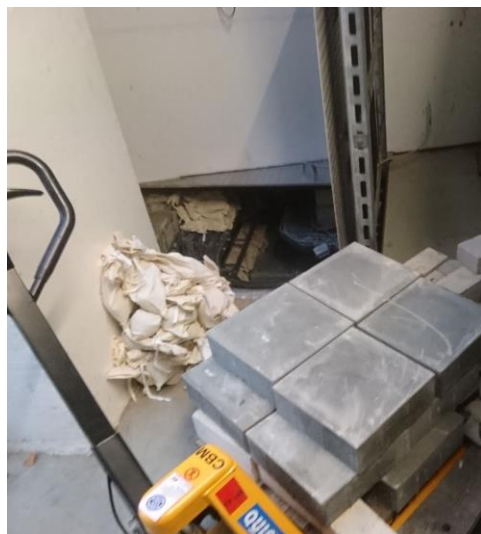
- Three openings in the concrete shielding walls closed:
 - cable tray
 - cable duct
 - better closing of holes in pion target bunker

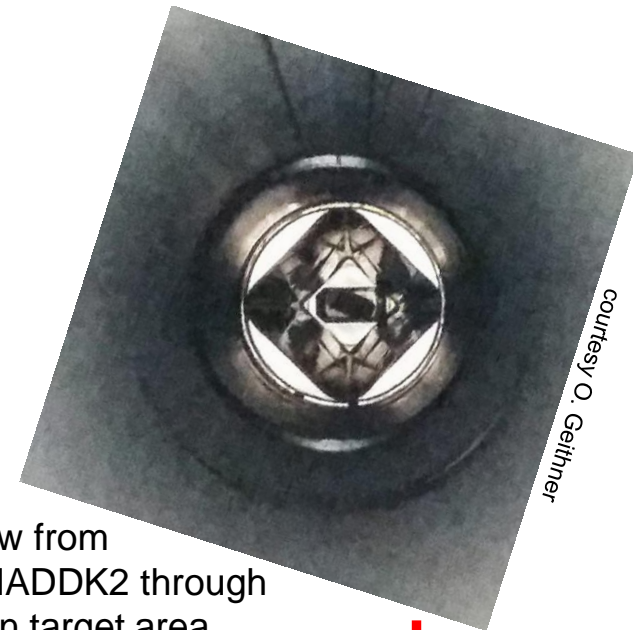
- Three sectors vented, opened in 6 places and inspected
 - GTH2DK2, GTH2DKY, GTH2DKA, bellow next to GHADKY1, bellow next to GHADDK2, GHADDK3
 - **no obstacles found**
 - SEM of a PDC in GHADDK3 slightly bend – repaired in situ
 - not enough activation to pinpoint beam loss location

view from GHADDK2 through pion target area
