HEST status

2018.09.25

m.sapinski

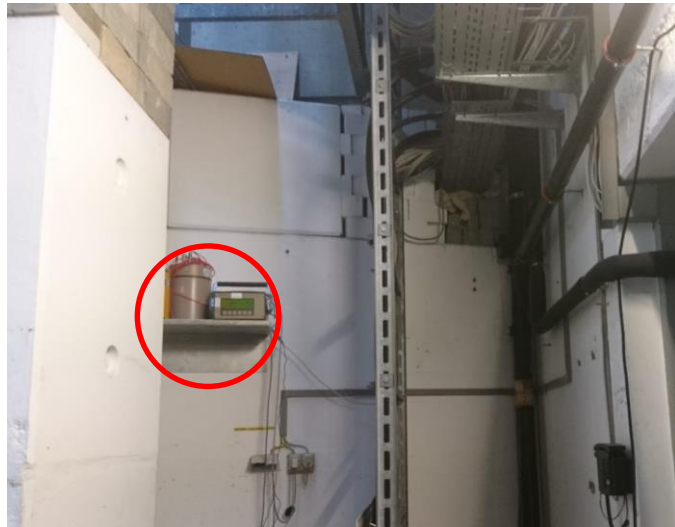
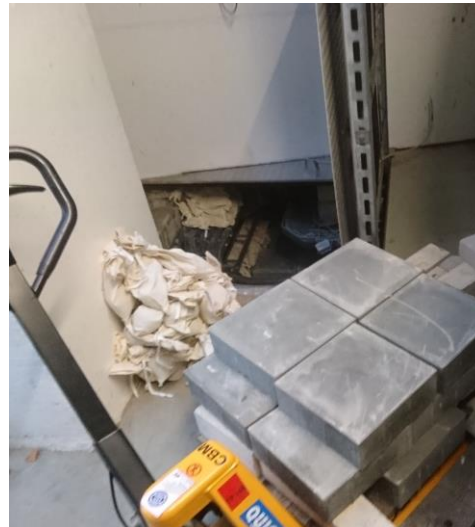
- Three openings in the concrete shielding walls closed:
 - cable tray
 - cable duct
 - better closing of holes in pion target bunker
