SoM-CAM test with FW4Y signals

HIPA instrumentation upgrade meeting
November 5th, 2024

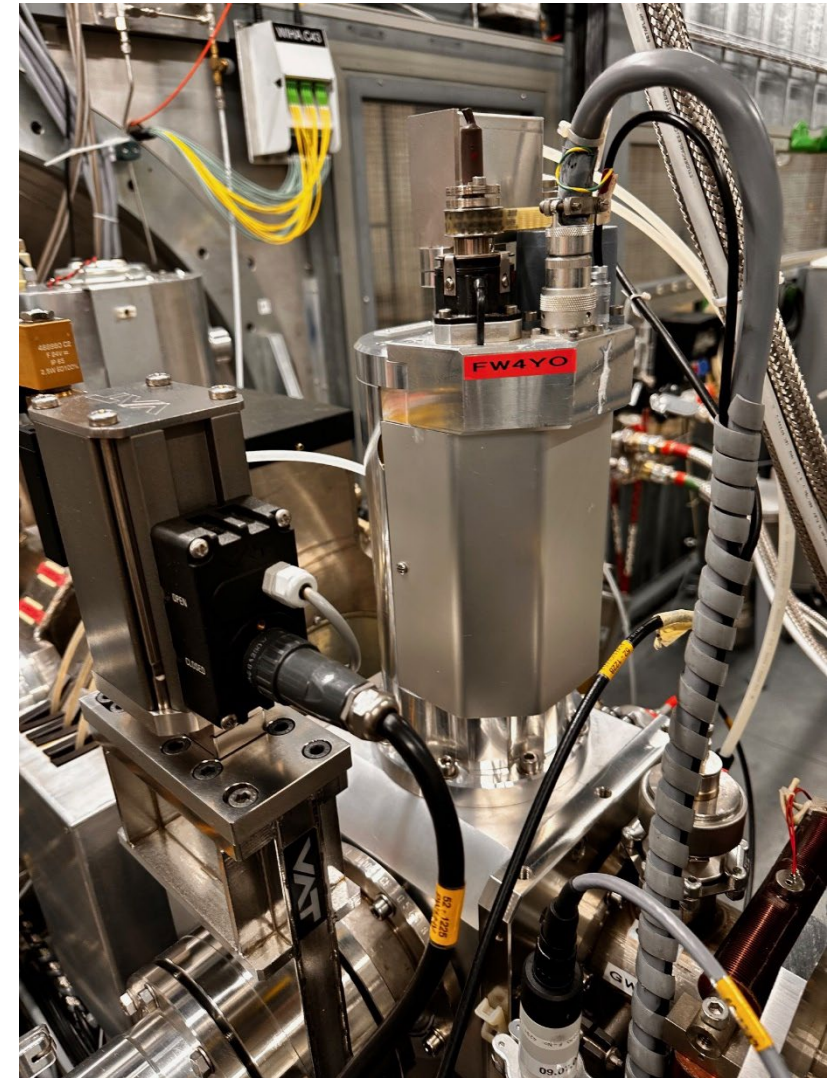
Location of the FW1,2,4 slits

Cockcroft Walton Detail

4. Rudolf suggested FW1,2,4 (FW3 does not exist) which are horizontal and vertical slits, because:
“If FW1 ... 4 are not moved far into the beam, what was historically often the case, I assume they are not endangered.
With the operators, they probably can be moved out.
For longer operation in this mode, eventually they can be blocked by switching off the driver module and removing the motor plug (Dietmar).”

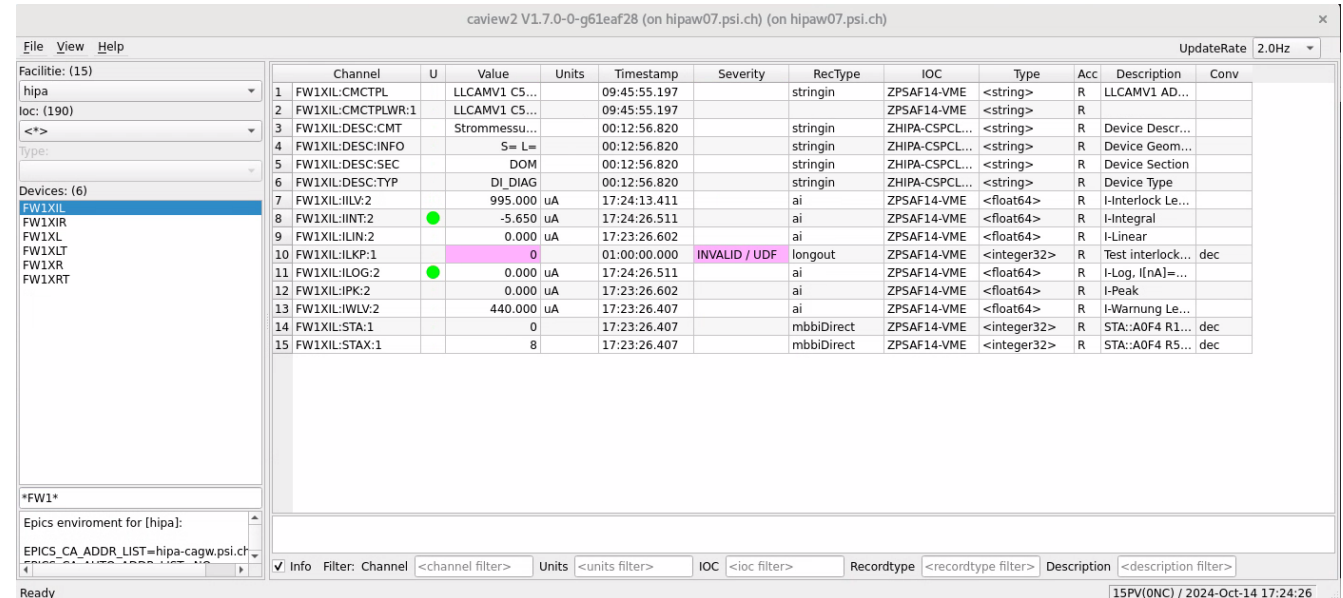
The screenshot shows the cview2 V1.7.0-0-g61eaf28 interface. The main table displays interlock data with columns: Channel, U, Value, Units, Timestamp, Severity, RecType, IOC, Type, Acc, Description, and Conv. The table lists various channels like FW1XIL:CMCTPL, FW1XIL:CMCTPLWR:1, FW1XIL:DESC:CMT, FW1XIL:DESC:INFO, FW1XIL:DESC:SEC, FW1XIL:DESC:TYP, FW1XIL:IILV:2, FW1XIL:IINT:2, FW1XIL:IILN:2, FW1XIL:ILKP:1, FW1XIL:ILOG:2, FW1XIL:IPK:2, FW1XIL:IWLTV:2, FW1XIL:STA:1, and FW1XIL:STAX:1. The 'Value' column shows values like 995.000, -5.650, 0.000, 0, 0.000, 0.000, 440.000, 0, and 8. The 'Units' column shows 'uA'. The 'Severity' column shows 'INVALID / UDF' for FW1XIL:ILKP:1. The 'RecType' column shows 'longout' for FW1XIL:ILKP:1. The 'IOC' column shows 'ZPSAF14-VME' for all entries. The 'Type' column shows '<string>' for FW1XIL:CMCTPL, FW1XIL:CMCTPLWR:1, FW1XIL:DESC:CMT, FW1XIL:DESC:INFO, FW1XIL:DESC:SEC, FW1XIL:DESC:TYP, FW1XIL:IILV:2, FW1XIL:IINT:2, FW1XIL:IILN:2, FW1XIL:ILKP:1, FW1XIL:ILOG:2, FW1XIL:IPK:2, FW1XIL:IWLTV:2, FW1XIL:STA:1, and FW1XIL:STAX:1. The 'Acc' column shows 'R' for all entries. The 'Description' column shows 'LLCAMV1 AD...', 'Device Descr...', 'Device Geom...', 'Device Section', 'Device Type', 'I-Interlock Le...', 'I-Integral', 'I-Linear', 'Test interlock...', 'I-Log, I[nA]=...', 'I-Peak', 'I-Warning Le...', 'STA::A0F4 R1...', and 'STA::A0F4 R5...'. The 'Conv' column shows 'dec' for FW1XIL:ILKP:1, FW1XIL:ILOG:2, FW1XIL:IPK:2, FW1XIL:IWLTV:2, FW1XIL:STA:1, and FW1XIL:STAX:1. The interface also includes a left sidebar with 'Facilities: (15)' and 'Devices: (6)', a bottom status bar, and a filter section.

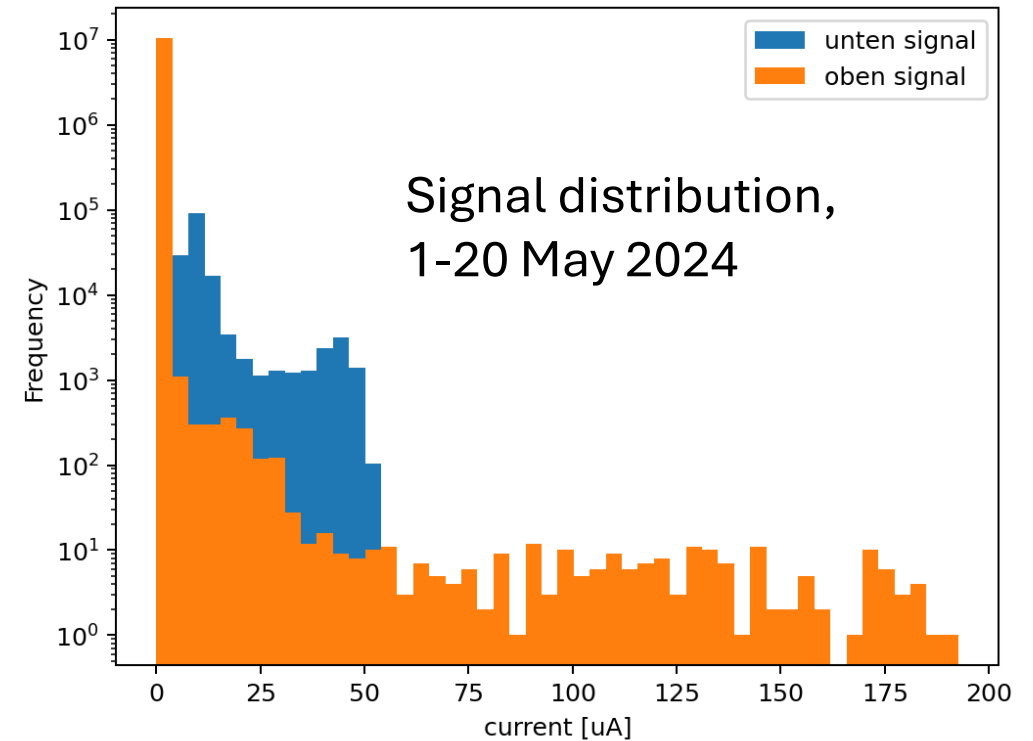
Some slit data from this year, before the test

Very small movement of the slits

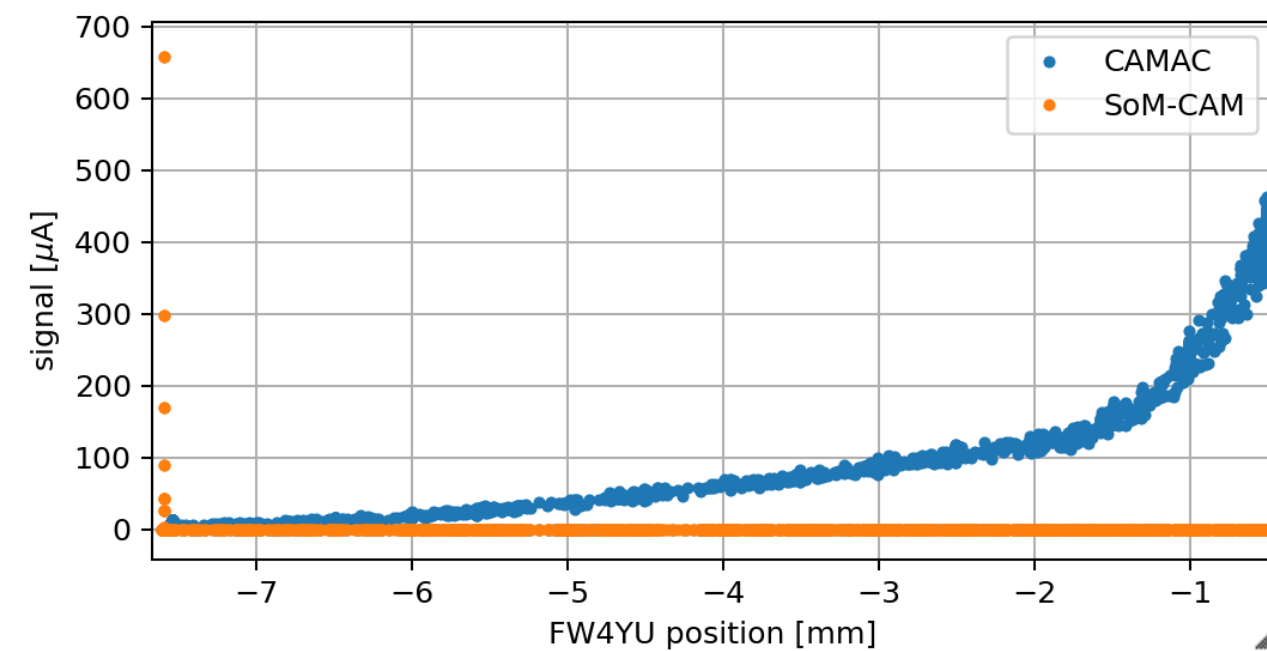
SoM-CAM channel 0, no filters

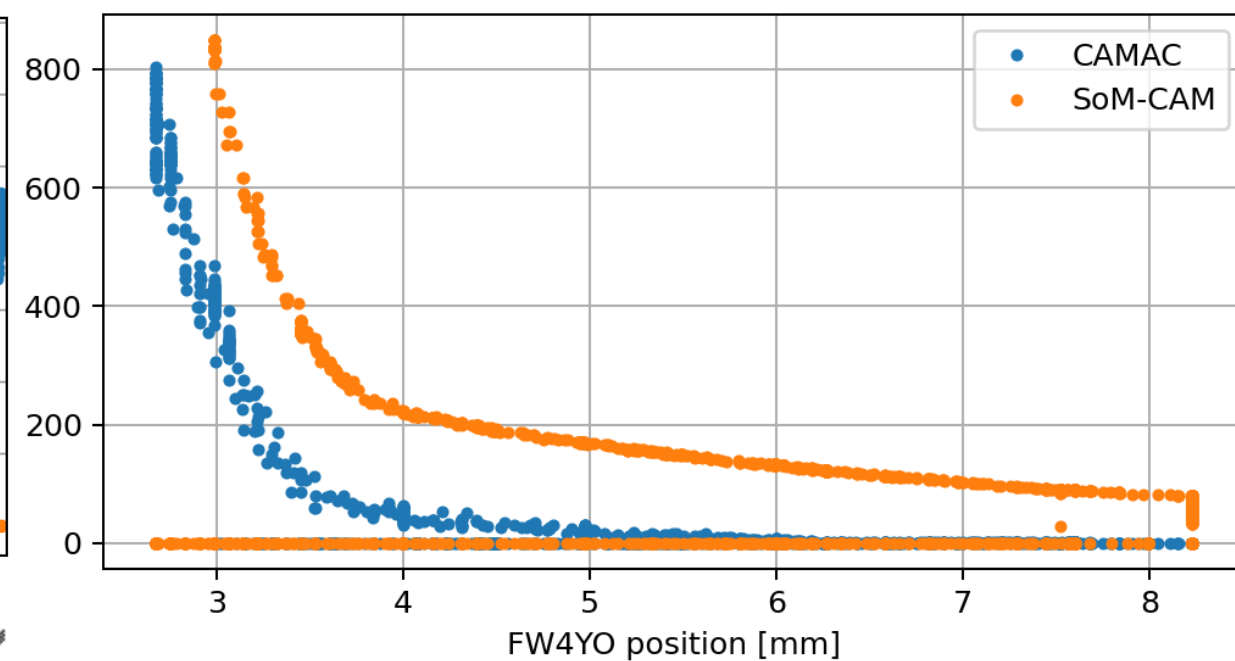
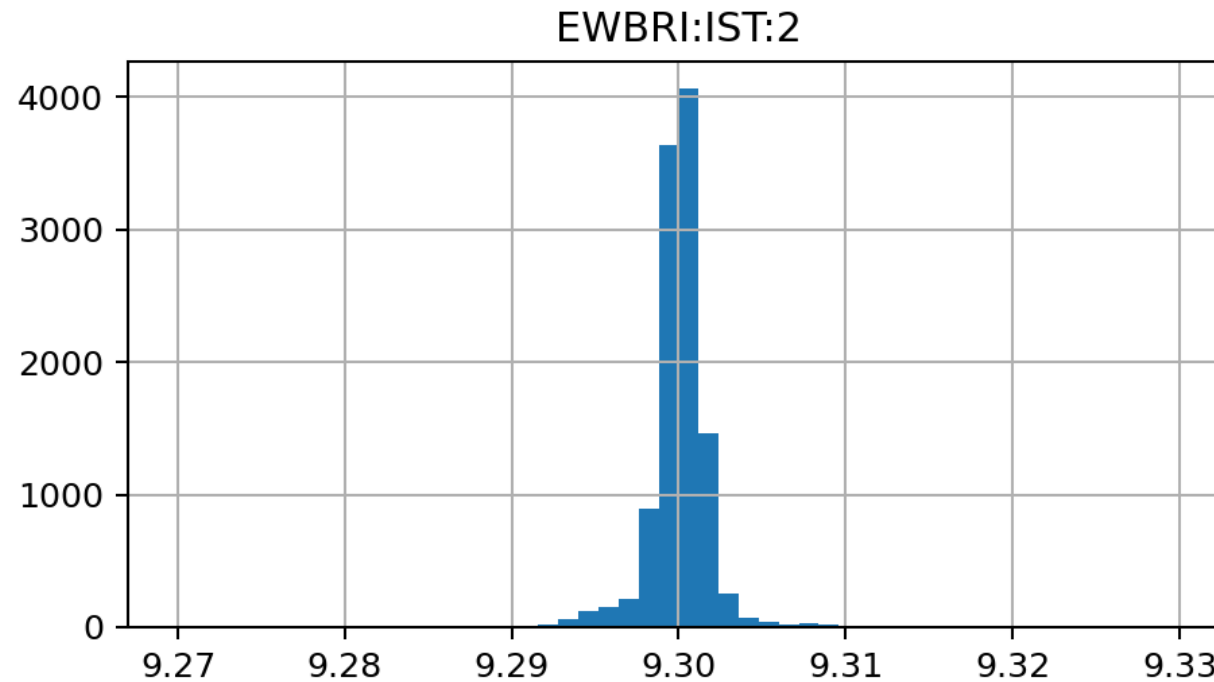
SoM-CAM channel 1, with both filters

Beam current is very stable, but maybe beam position/width not?

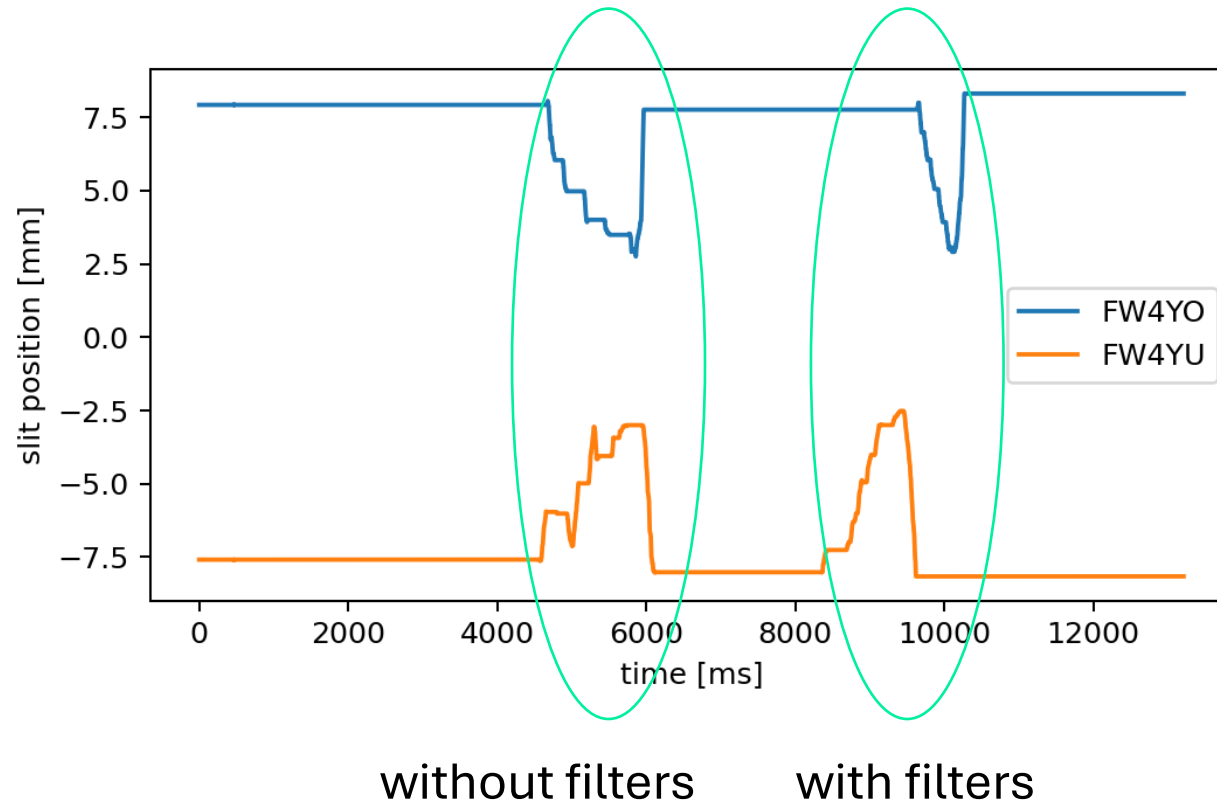
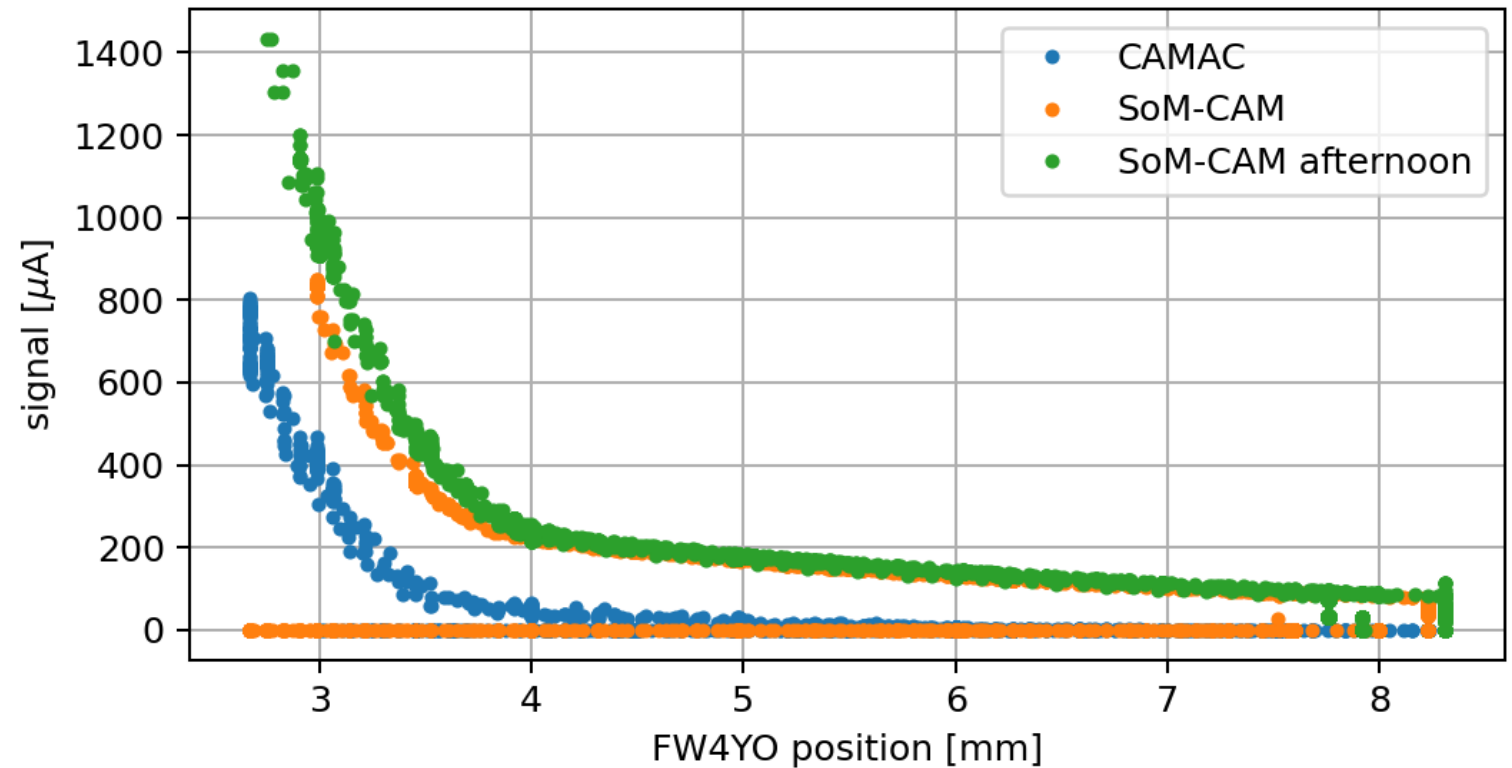
Afternoon data

- Green: afternoon data with and without filters together
- Filters seem to make no difference
- SoM-CAM morning and afternoon data similar
- Significantly higher SoM-CAM signals wrt. LLCam

- Very useful test, unpredicted conditions (174 V potential).
- Important lesson concerning human safety! Unpleasant potential even on low-current signal cables!
- (BTW: do we understand this 174 V?)
- SoM-CAM readings are higher than LLCam. There is a shift (88-131 μA) and a coefficient (2.4-3.4)

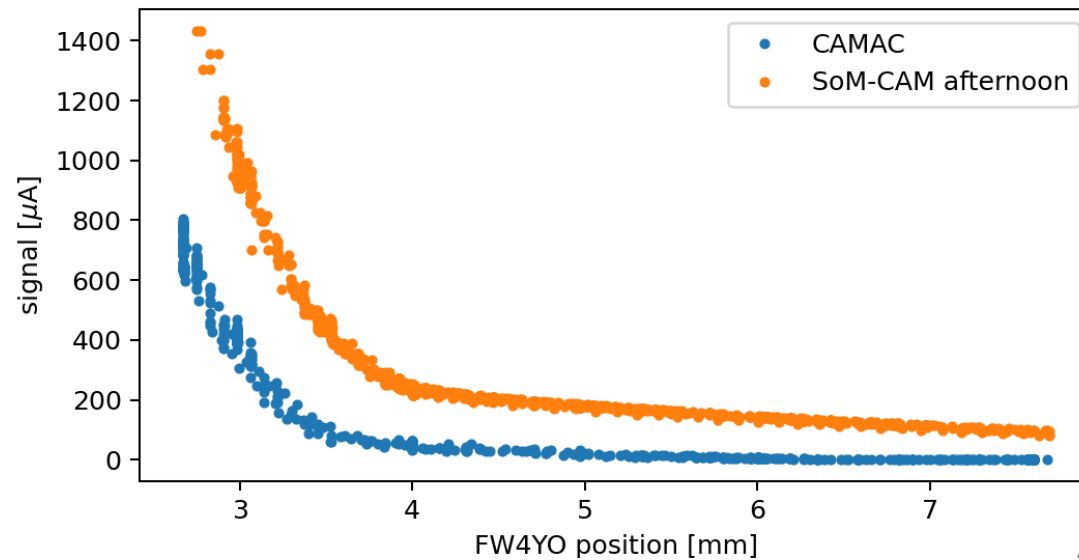
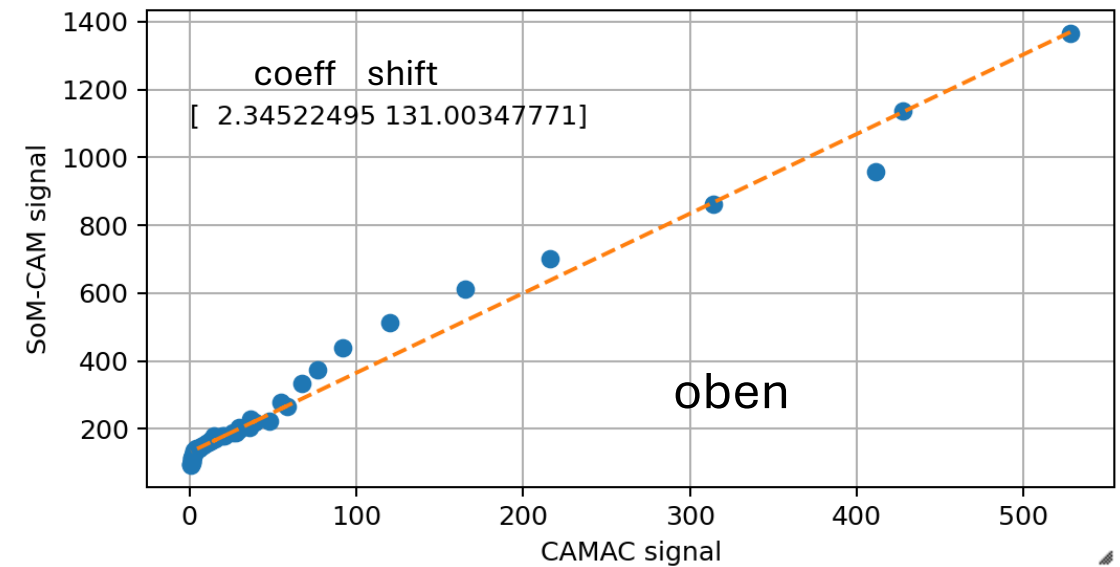
- Compare only afternoon SoM-CAM data with morning LLCam data

Fit: $y = ax + b$
