Mariusz Sapinski :: Paul Scherrer Institut

How high-power accelerators damage thin wires?

Low Density Materials for Beam Instrumentation, CERN, June 20th, 2023

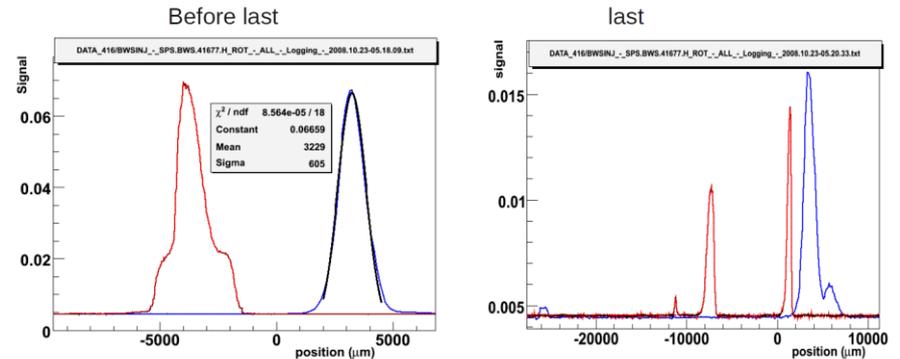
Breakage of 416H: data

Observation: the last OUT scan shows huge vibrations or wire breakage along the wire (multiple pass of the beam)

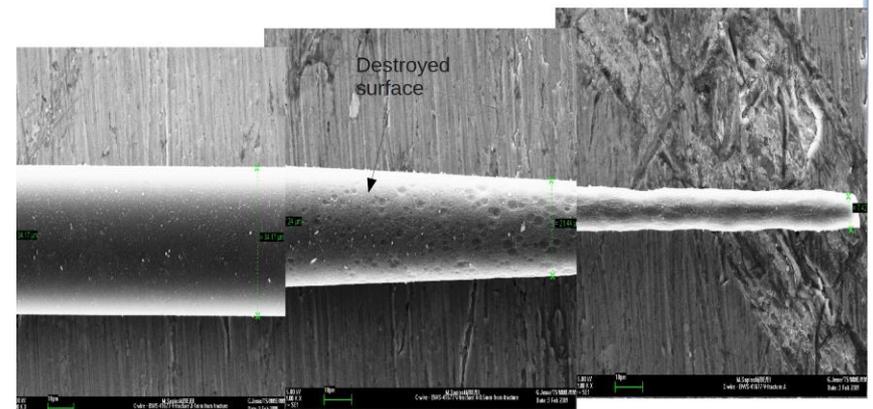
Breakage of 416V: post-mortem (2)

- Scanners used: 416V, 416H
 - 450 GeV proton beam, coasting (reduce RF)
 - Breakage at 50-70 cm/s (nominal 6 m/s)
 - Scans before breakage suggest strong wire deformation and/or vibrations
 - Electron microscope analysis shows significant sublimation, from 34 μm diameter down to about 6 μm diameter down to about 6 μm
 - Model predicts temperature ~ 3500 K
 - 95% of material sublimated before the wire breakage,
- carbon fiber is truly a strong material**
- Sublimation increases surface-to-volume ratio, leading to better thermal behaviour
 - As a result of these experiments the limits for LHC scanners were established

see: "Carbon Fiber Damage in Accelerator Beam", proceedings of DIPAC 2009, CERN-BE-2009-028

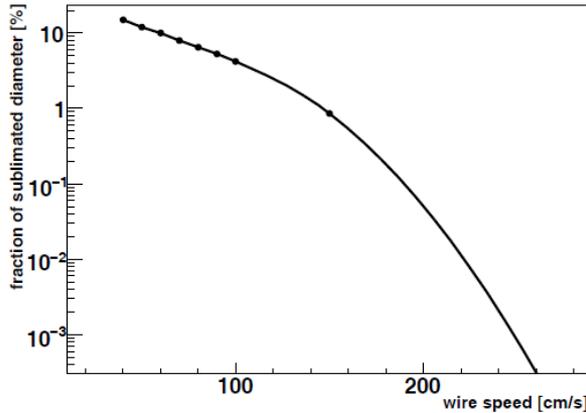
Sublimation calculation

- In vacuum graphite does not melt, it sublimates
- Sublimation rate can be calculated using simplified model assuming steady-state conditions:

- vapour density computed from vapour pressure
- Measurements: 2 times more material sublimated than foreseen by the model, what is large error but not completely crazy result

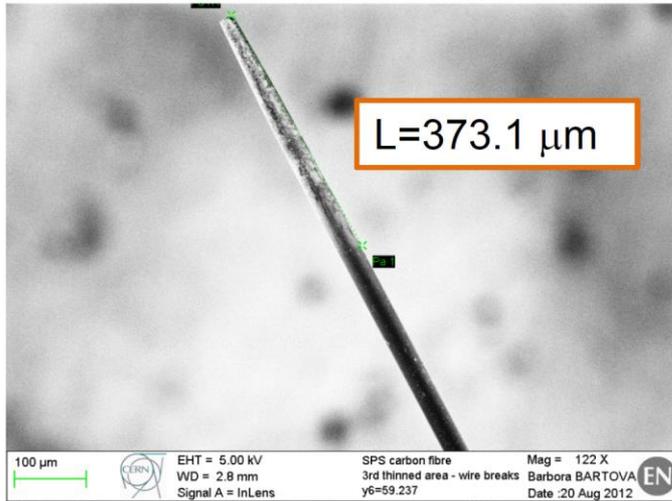
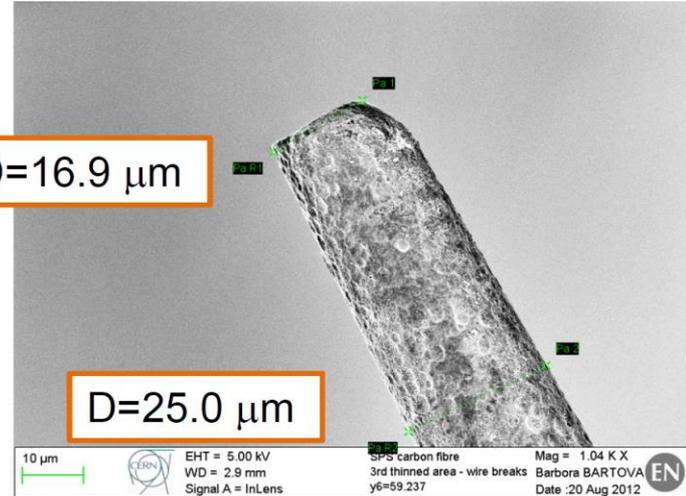
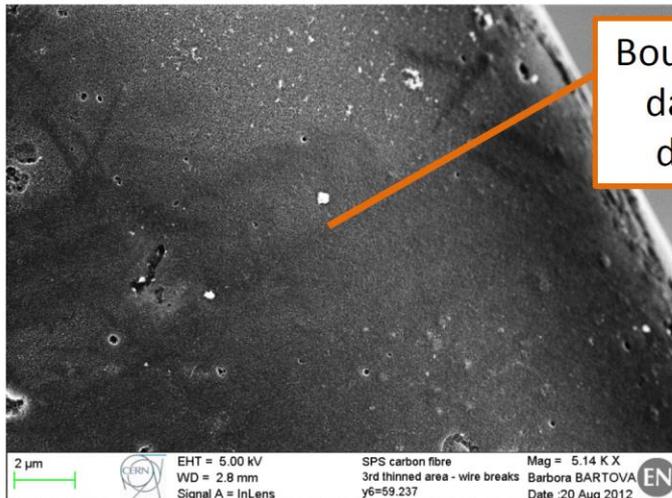
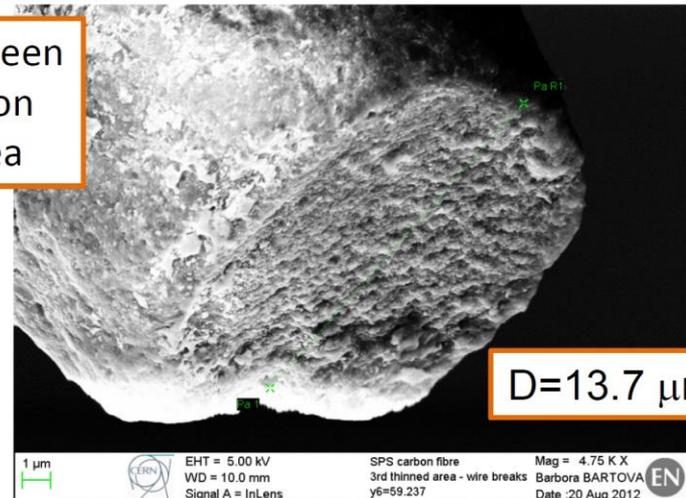
SPS breakages (protons, 2012)

- Experiment in which wire was irradiated in 3 places with increasing intensities
- Surface damage already at relatively low intensities, **sublimation damage consistent with previous observations**

Boundary between damaged – non damaged area

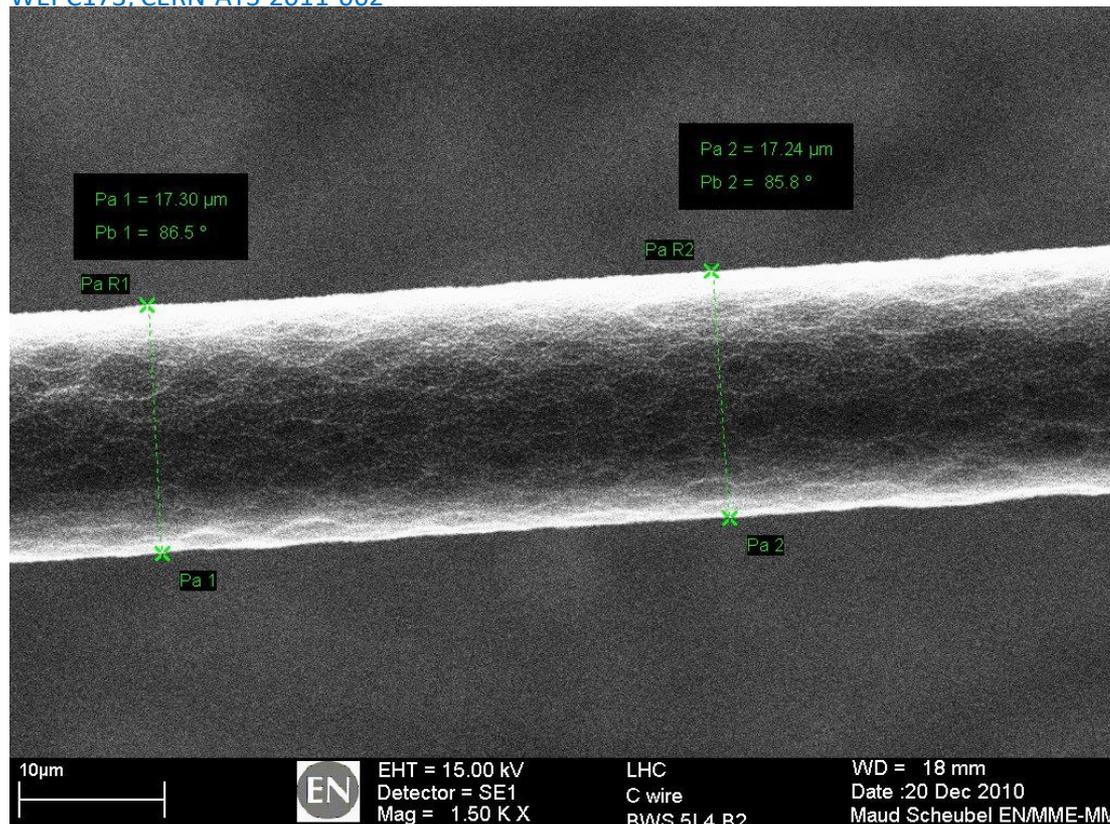
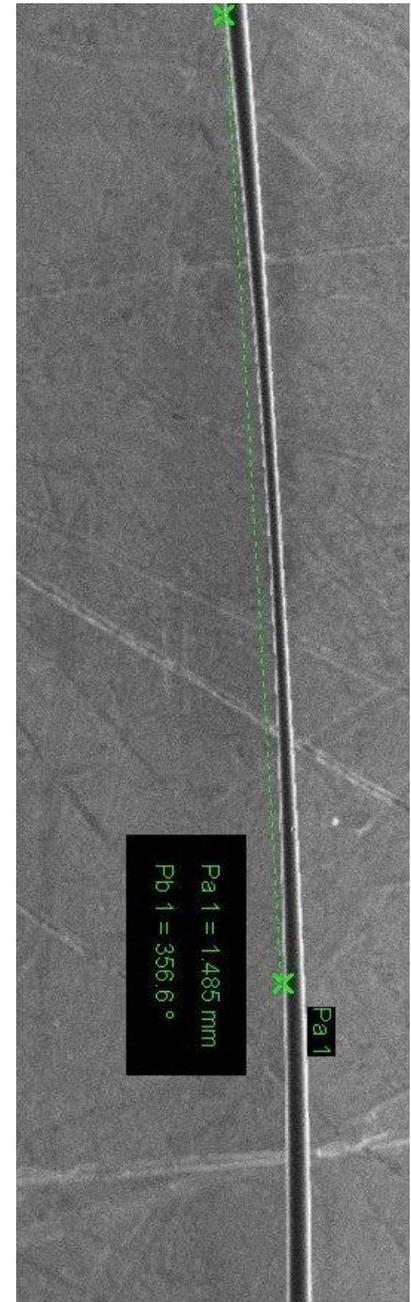
LHC quench test (protons, 2010)

- 3.5 TeV proton beam
- Goal: **to quench the superconducting magnet NOT to damage the wire**
- Wire recovered in one piece
- Analysis with electron microscope: familiar sublimation images

see: "LHC magnet quench test with beam loss generated by wire scan", in Proceedings of IPAC11, WEPC173, CERN-ATS-2011-062

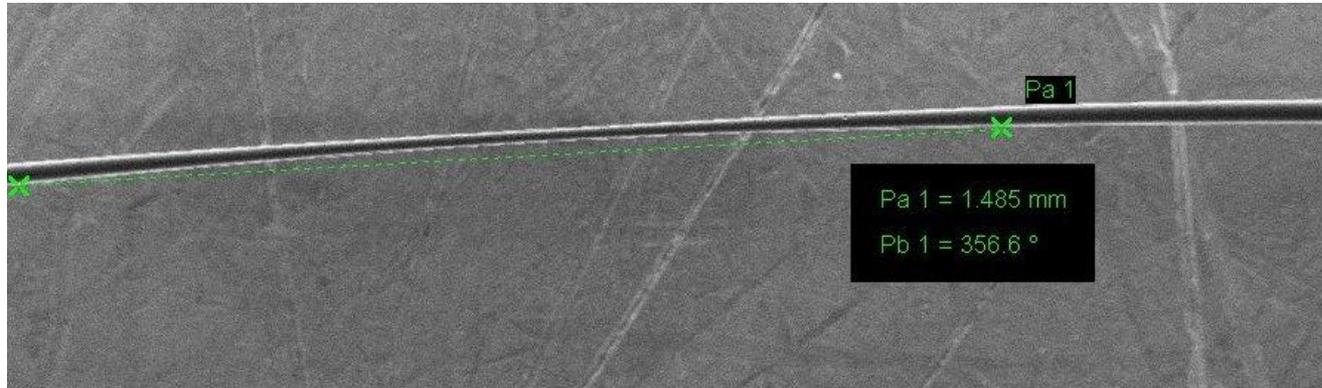
Pitfalls of sublimation

- One may think that **controlled sublimation** is a legitimate wire scanner operational mode but:

- Thinner wire = less signal from the beam center → potential measured profile deformation
- Fortunately, because of “stabilizing effect” of thermionic emission on temperature, effect is not as strong as one could think, but still “controlled sublimation” operation is not recommended

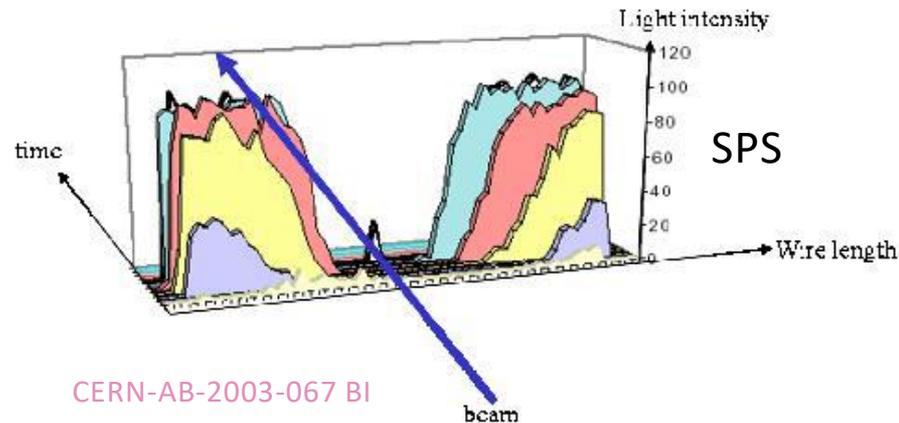
RF damage

- RF can be generated by beam or can **leak from RF cavities**
- Metal or semimetal (graphite) **wire is a good antenna**, therefore there is a rich record of wire damage due to coupling to RF
- RF can break wire without the beam (in parking position)

- Countermeasures:
 - Damping RF using ferrites
 - Changing tank geometry
 - RF shields

- RF heating is typically at the ends of the wire (no overlap with beam)
- In CERN case the ends are copper-plated; different thermal expansion coefficients
- In PSI case the breakage occurs at the glue surface

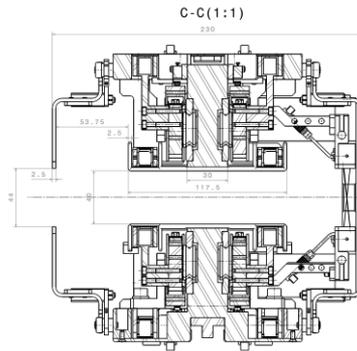
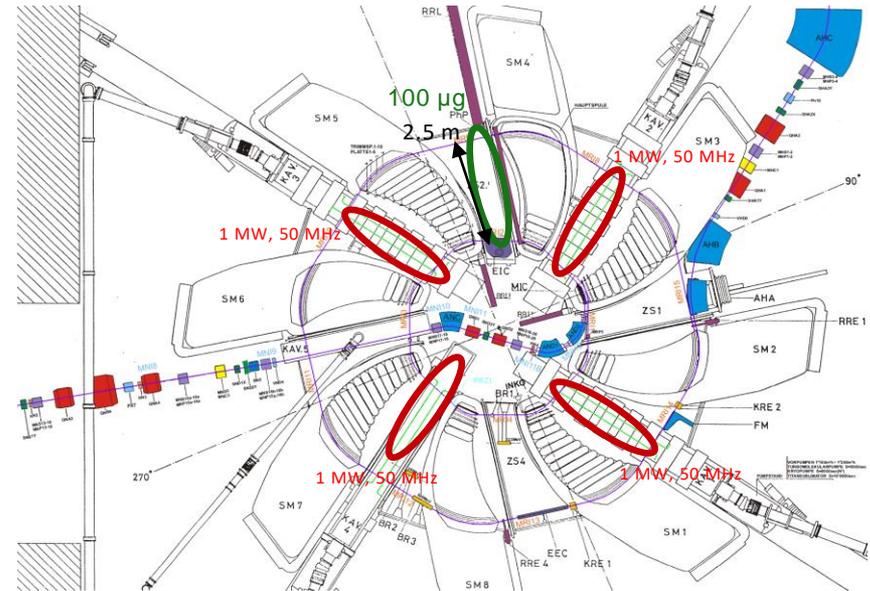
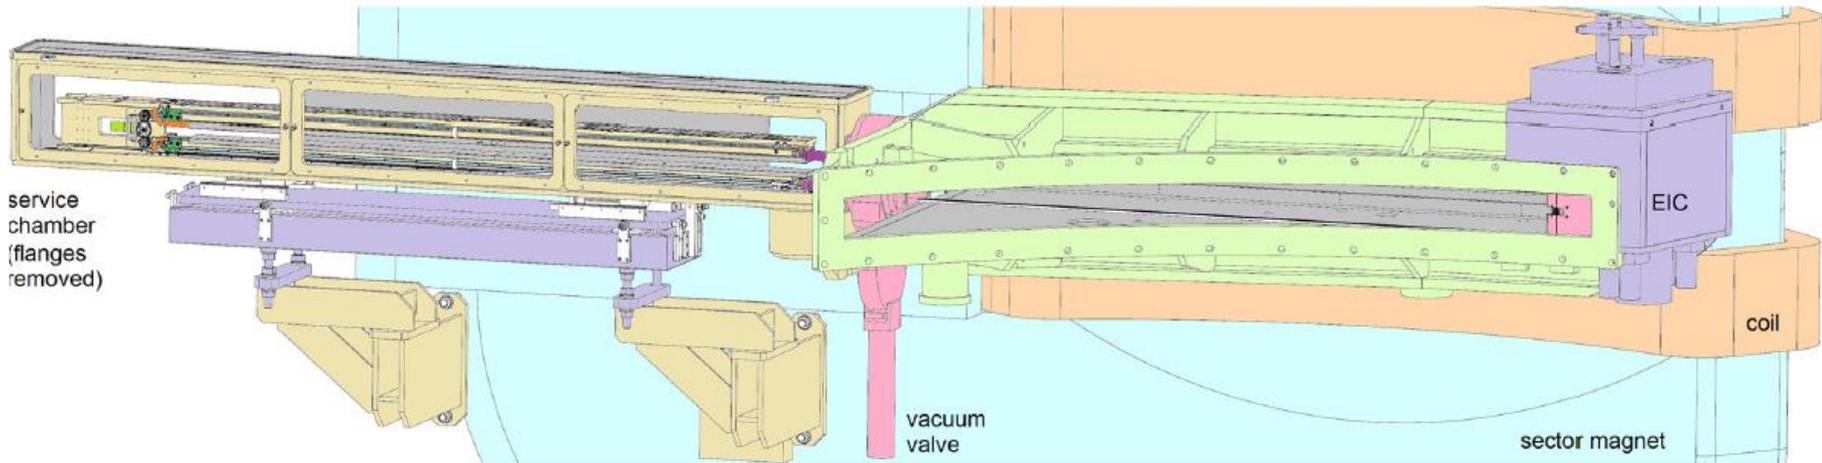
RF damage in cyclotron

- Sector cyclotrons are **filled with cavities**
- Long radial probe is a special, very long (2.5 m) wire scanner designed to scan all turns (180) of a cyclotron
- RF shields in anticipation of problems

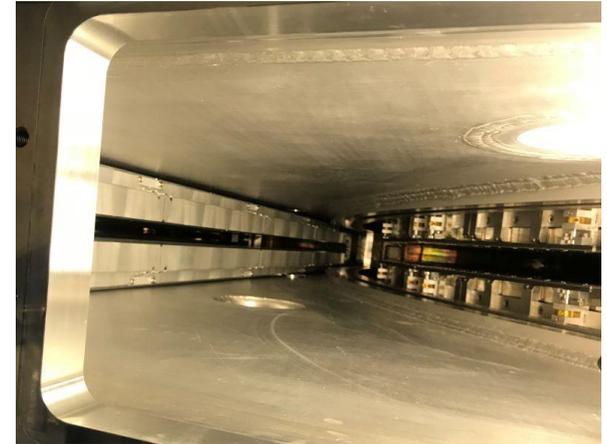
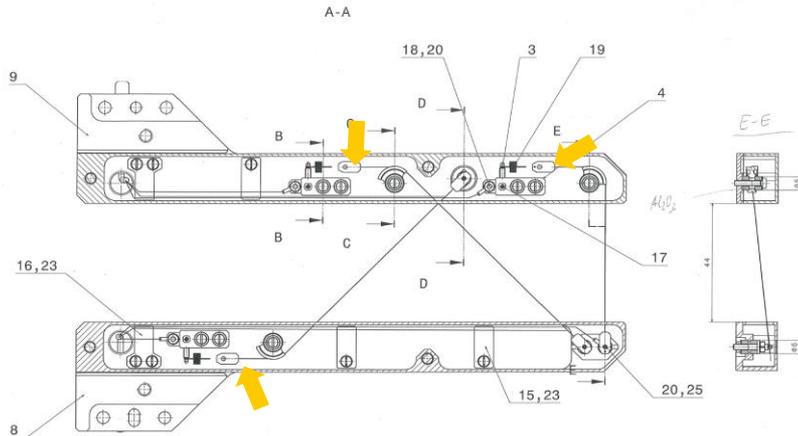
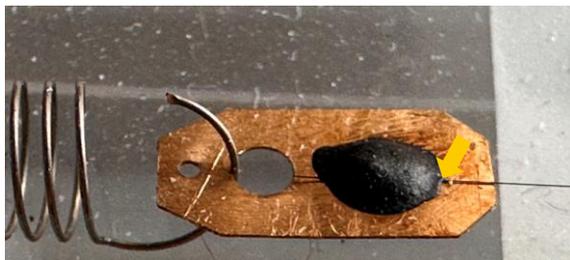
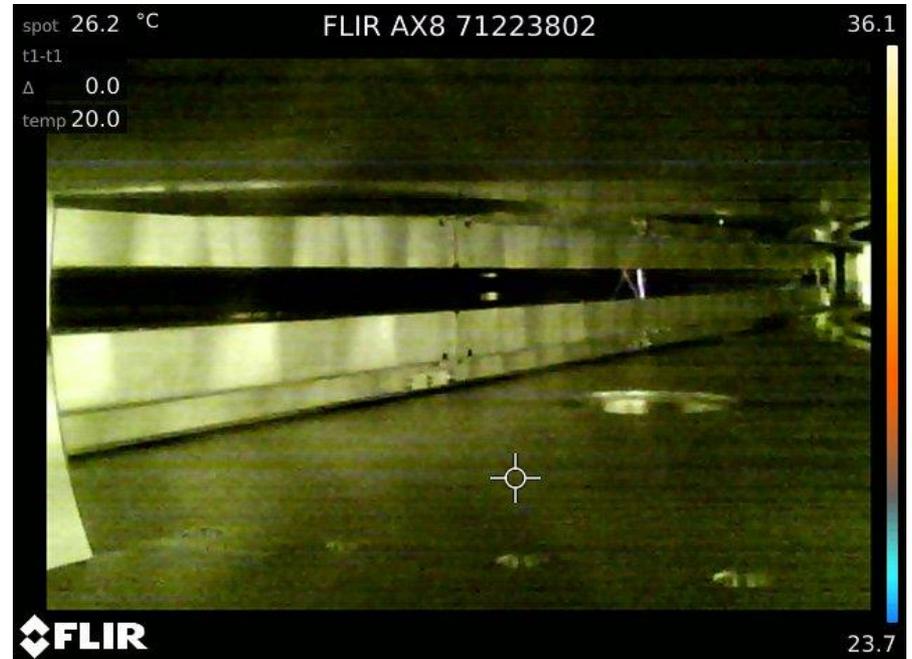
RF damage in cyclotron - observations

- Wire getting hotter towards the center of the cyclotron
- Breakage usually at wire bending or wire-glue interface
- Breakage when neighboring cavities are powered asymmetrically (eg. one on and one off)

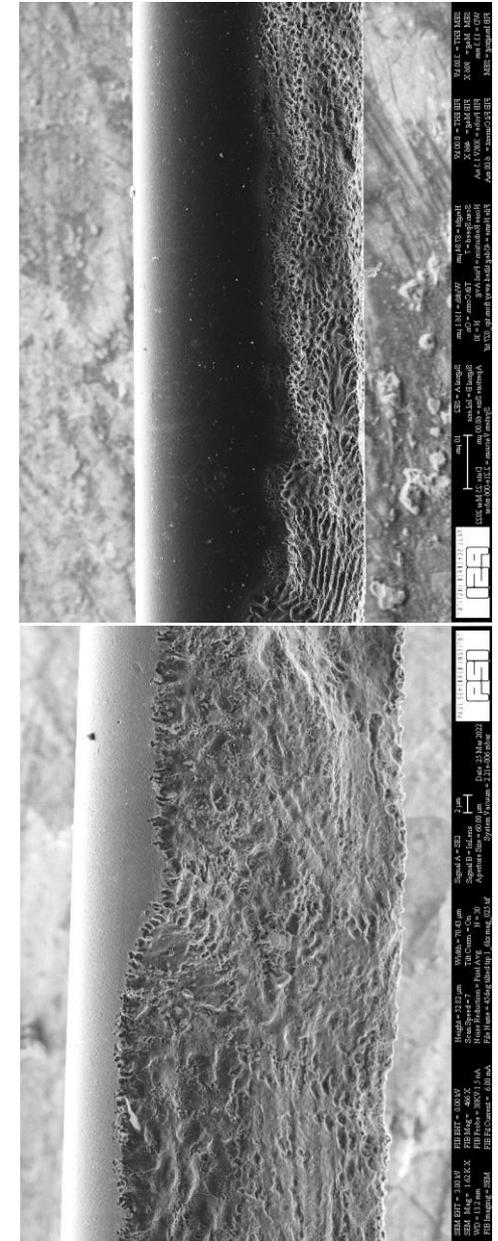
RF damage in cyclotron - observations

- RF imbalance leads to imminent breakage
- Skin effect? Let's check:

- $\rho = 8 \cdot 10^{-6}$ [Ωm] – at room temperature
- $\mu = 1.26 \cdot 10^{-4}$ [H/m]
- $\omega = 2 \pi 50$ [$\text{rad} \cdot \text{MHz}$]
- $\rightarrow \delta = 19 \mu\text{m}$ – close enough!
- It is possible that RF leaking from opposite cavities undergo destructive interference in the location of the wire saving it from damage

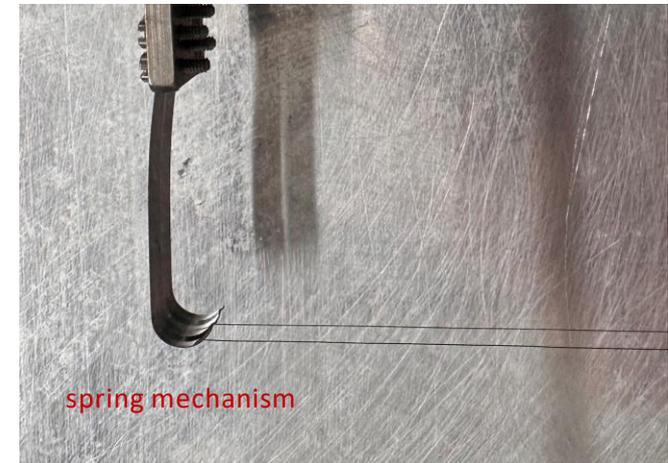
Damage event

- In 2022 a brand new wire in a wire scanner on Ultra Cold Neutron beamline **broke after ~20 scans**
- For each scan the beam conditions were always the same:
 - Beam current 1.8 mA
 - Beam energy 590 MeV
 - Beam size: $\sigma_H = 6.2$ mm, $\sigma_V = 1.3$ mm (very asymmetric)
 - Wire speed 60 mm/s
- During the consecutive scans **thermionic emission appeared and steadily increased**

- The **increase of the thermionic emission could be due the cracking of the wire surface** which lead to decrease of work function
- Some prior observations of similar effects exist

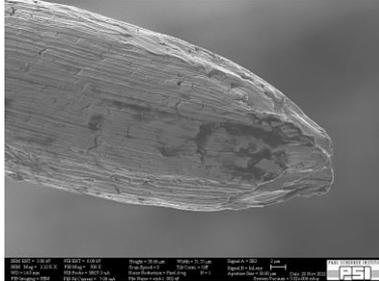
necking

- Electron microscope analysis revealed characteristics of ductile damage

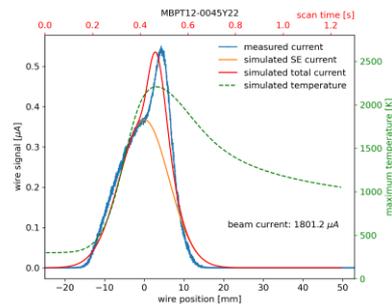
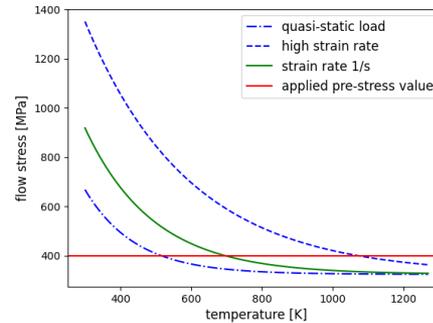
- Thermal simulation show temperatures far from melting, but easily exceeding the flow stress value at higher temperatures
