PSI Center for Accelerator Science
and Engineering

Radiation damage to MHP45/46 magnetically coupled linear drive

M. Sapinski
PSI, HIMB Instrumentation meeting, 23 March 2026

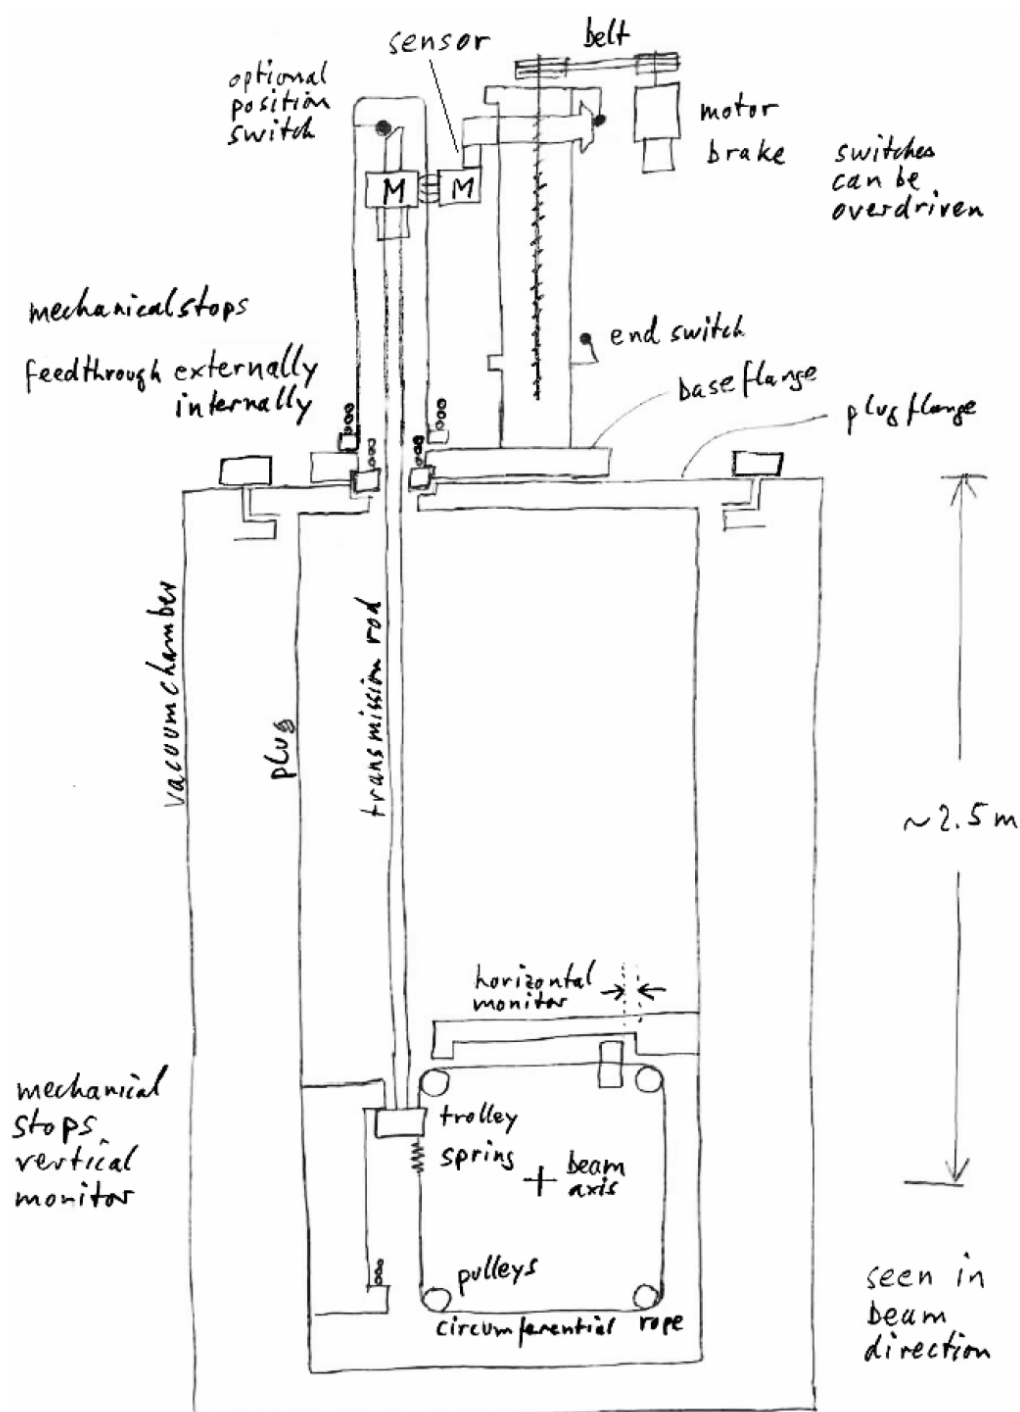
- MBPT1 and MHP45/46 use magnetically-coupled linear drive with NdFe permanent magnets.
- This is an elegant solution (motor does not have to counteract atmospheric pressure).
- But permanent magnets suffer from radiation damage. Literature shows that after 10^{17} n/cm² magnets may completely lose their properties.
- SmCo magnets withstand much higher dose, but they contain Cobalt, which becomes very radioactive.

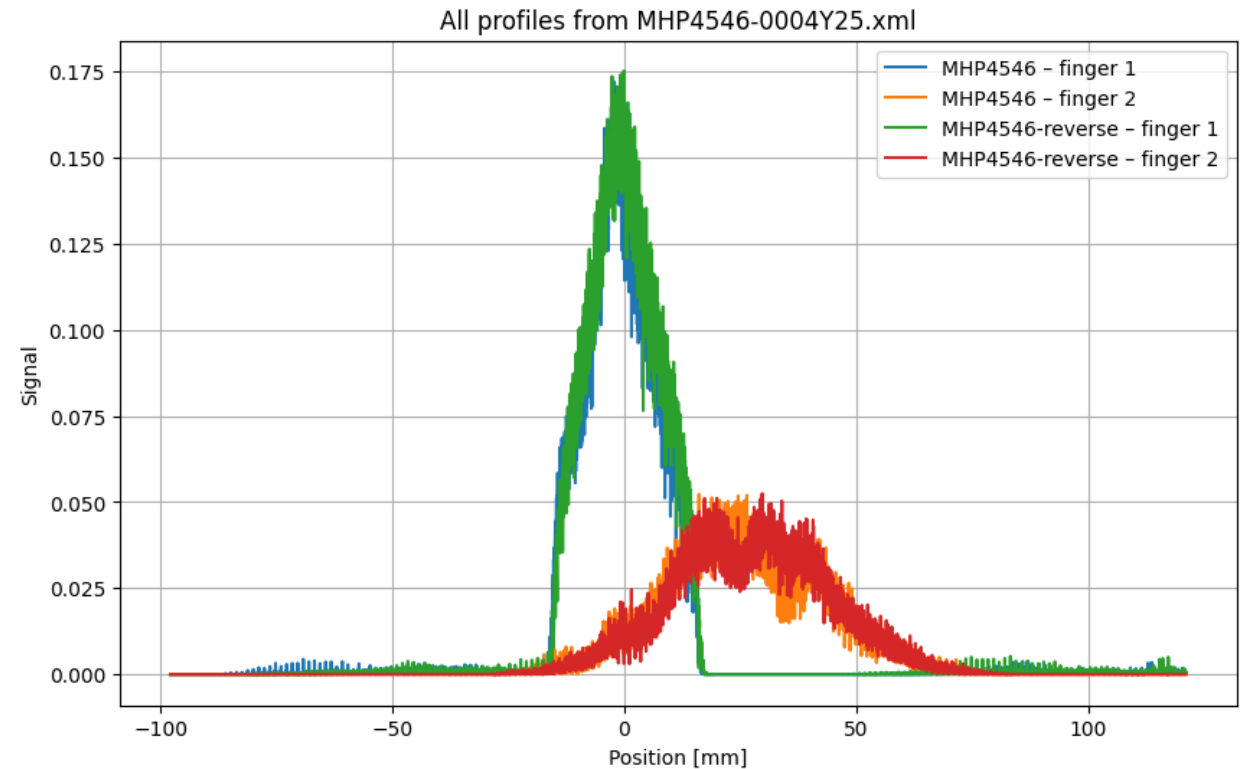
MHP45/46 usage

- In 2024 MHP34/46 was used 126 Times (commissioning phase).
- In 2025 we have used it only 4 times, last time December 18th, 2025.
