# Strahentwicklung October 10<sup>th</sup>, 2024

## – MXB2B and RRL

M. Sapinski  
PSI, Oct 16<sup>th</sup>, 2024

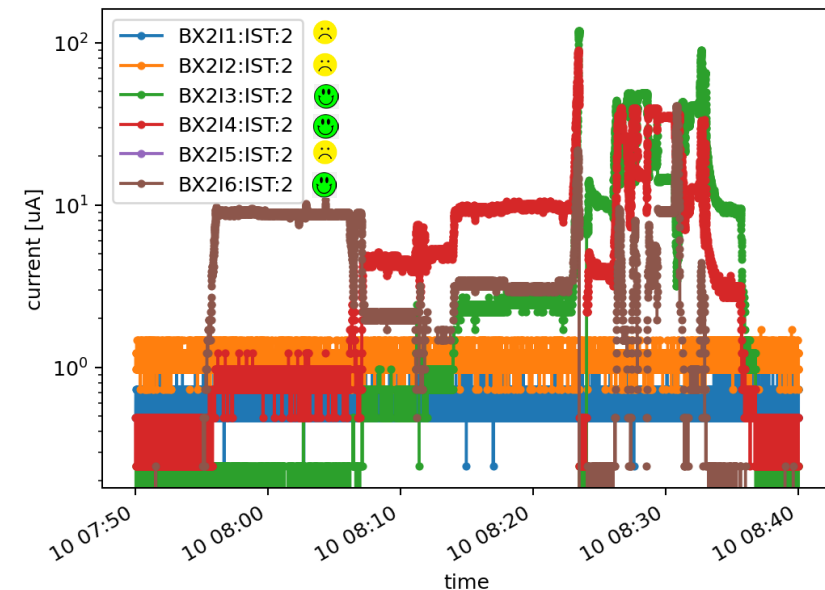
# MXB2B issues

Aug 14, 2024, MBX2B

- Injector 2 setup data, beam current up to 2 mA
- Lack of signal from bottom foil (U = unten)
- Strange signal from left foil

- Lack of signal from bottom foil
- Strange, low signal from left foil again

- The position interlock must be bridged!
- We have spare for this blende
- Status of MXB2A? No signals observed last week, but there are some in DB.
